A Summary of Reconnaissance Efforts of the Multidisciplinary Center for Earthquake Engineering Research

## POST-TSUNAMI URBAN DAMAGE SURVEY IN THAILAND USING THE VIEWS<sup>®</sup> RECONNAISSANCE SYSTEM

**Shubharoop Ghosh, Beverley J. Adams, Charles K. Huyck, Michael Mio, Ronald T. Eguchi, Fumio Yamazaki and Masashi Matsuoka**

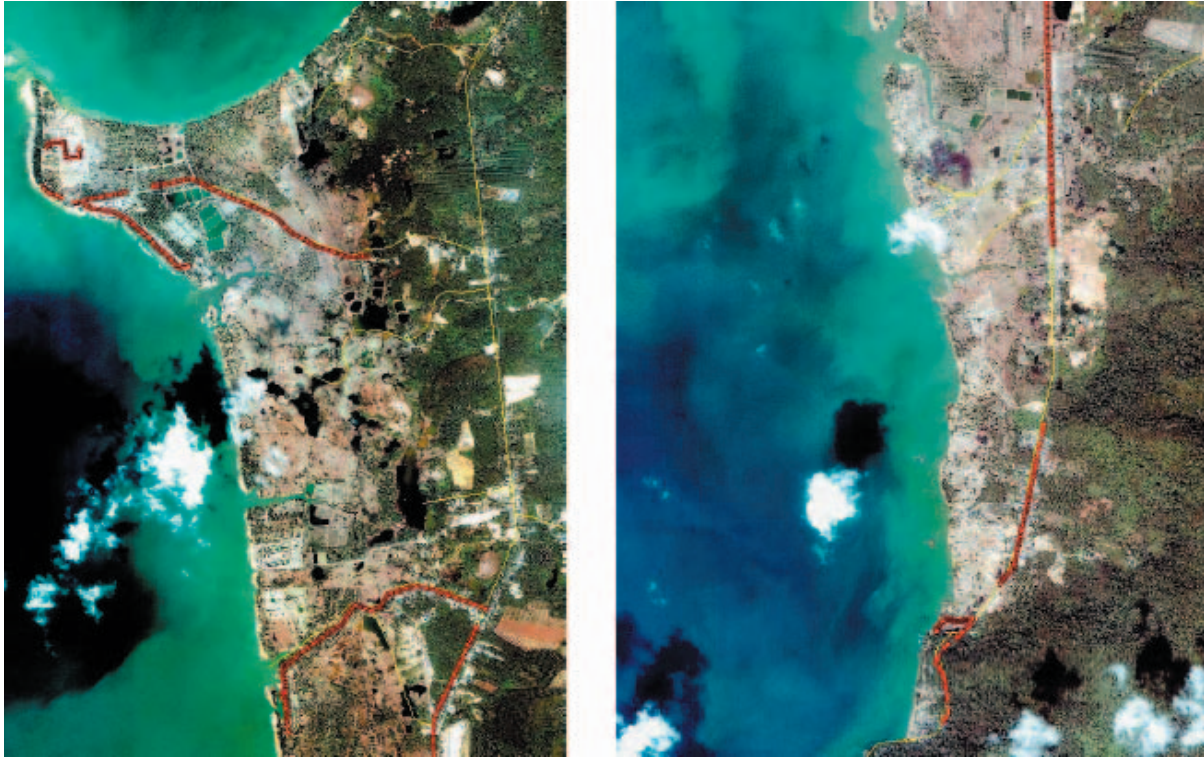
Figure 4. A selection of routes (red dots) through the Khao Lak area in Phang Nga province along which GPS readings, georeferenced video coverage and photographic record were collected from a moving vehicle, as well as on foot.

The damage survey was conducted from a moving vehicle in areas of Phang Nga (see Figure 4) and Phuket where there was vehicular access to damaged coastal regions. The team selected a van as the optimum type of vehicle, since it provided increased elevation above street level, and better video footage by avoiding obstructions in the foreground. The vehicle was driven at around 10-15 mph, as this speed minimized aberration in the video and stills, while enabling a large geographic area to be covered.

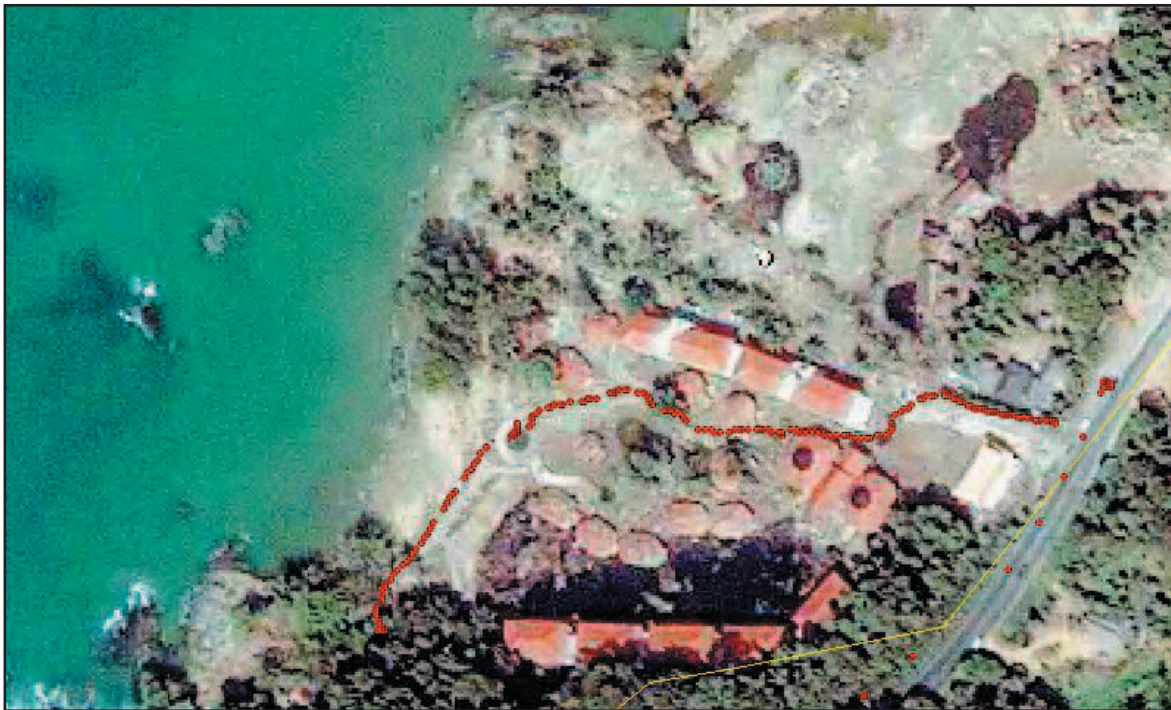
Figure 5. An example of a survey location in a heavily damaged Khao Lak resort in Phang Nga where foot based deployment was undertaken. The survey route is depicted by GPS points (red dots) along which georeferenced video and photographs were collected.

Damage data collection was conducted on foot throughout the three areas of Phang Nga, Phi Phi, and Phuket, where vehicular access was limited (see, for example, Figure 5). On the island of Phi Phi, which suffered extensive building and infrastructure damage, the only possible option for

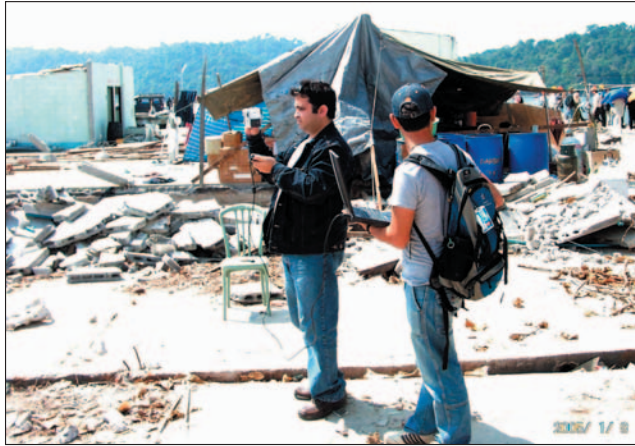
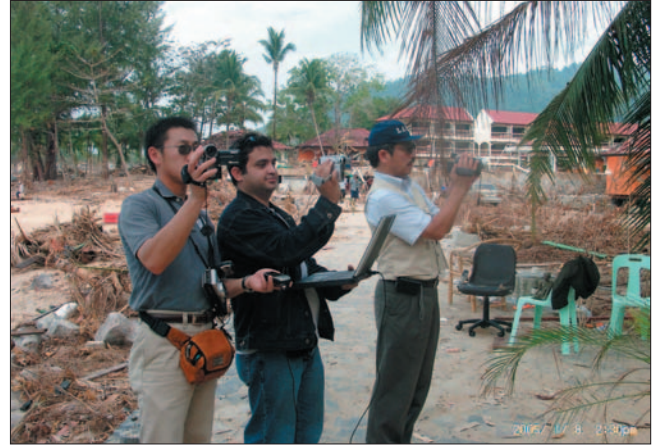
(a) VIEWS deployment with one camera

(b) VIEWS deployment with three cameras

Figure 6. Field deployment of the VIEWS system following tsunamis in Thailand, (a) Using a single video camera, and (b) Using multiple video cameras.

For this study, a new approach for data collection was adopted (Figure 6) by deploying three video cameras that simultaneously captured footage from three directions (front, left, and right). This streamlined the video collection process and provided a wider view of the area. The approach of collecting “panoramic” video data was implemented from both the van and on foot, and was used in some of the heavily affected areas of Phang Nga and Phi Phi. An alternative handheld-based approach was also tested for collecting GPS points. A Garmin iQue® Handheld with built-in GPS receiver was used to continuously collect GPS points in the survey sites where IEWS was deployed.

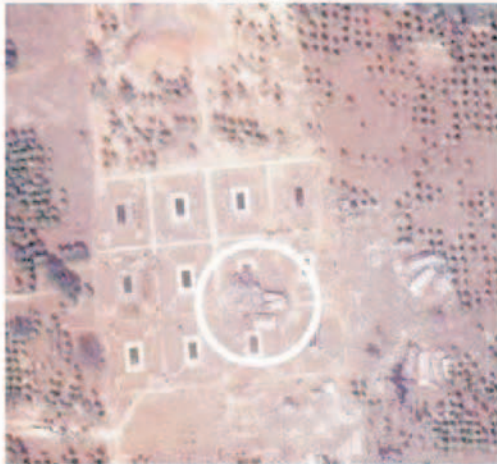
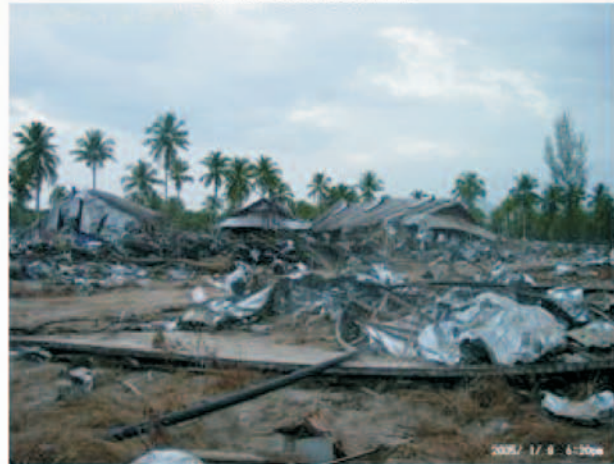
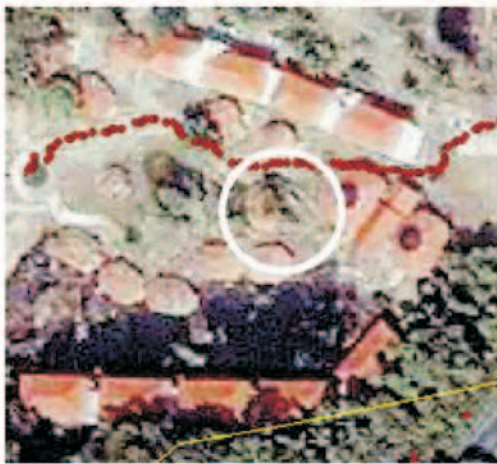
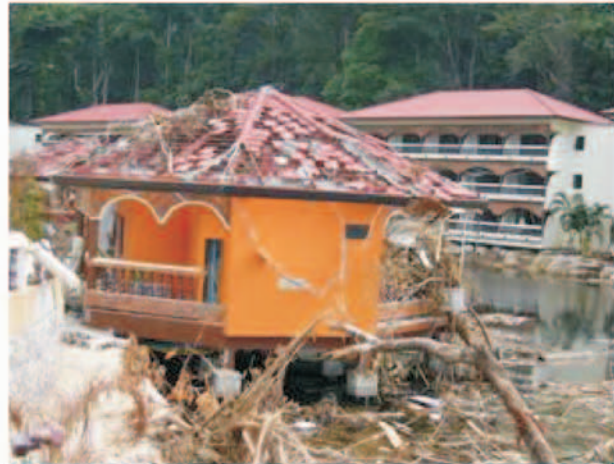
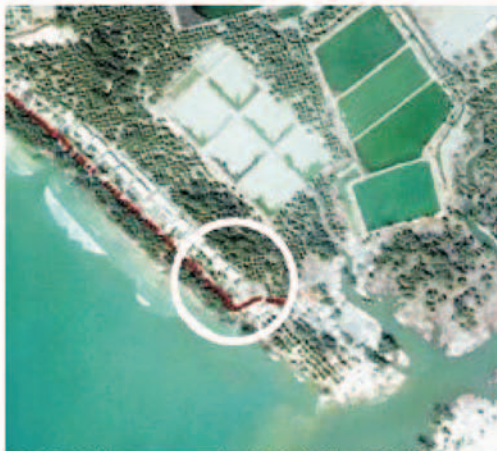
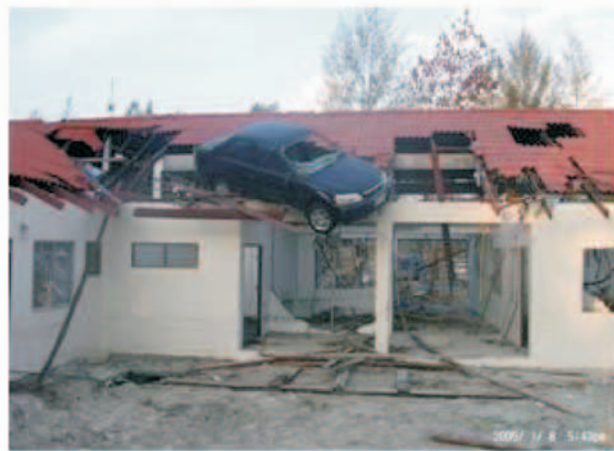
As shown in Figure 8(a) and 8(b), commercial structures in Phang Nga (Khao Lak area) were among the hardest hit due to the area's long and narrow stretch of exposed coastline. NOAA reported these areas recorded tsunami wave heights of up to 11 meters. Most of the resorts surveyed sustained heavy to complete damage. Phi Phi Island hotels and resorts were also among the worst affected with most resorts in Ton Sai Bay closed in the aftermath of the huge waves that swept across the island. Damage to commercial structures in Phuket was mixed, ranging from extensive to minor or no damage.

Figure 8. Tsunami damage photos of commercial/government structures in Phang Nga: (a) Completely destroyed Bamboo Orchid Resort; (b) Heavily damaged Similana resort; (c) Heavily damaged Phang Nga government building.

The following examples in Figure 8 show tsunami damage footage collected together with “after” satellite coverage. The areas studied included tourist resorts (Phang Nga, Phi Phi, Phuket) and fisherman’s villages (Phang Nga) along the coast. Structures in these areas were mostly commercial or residential. In addition, there were some commercial structures for the shrimp industry and a few government buildings.

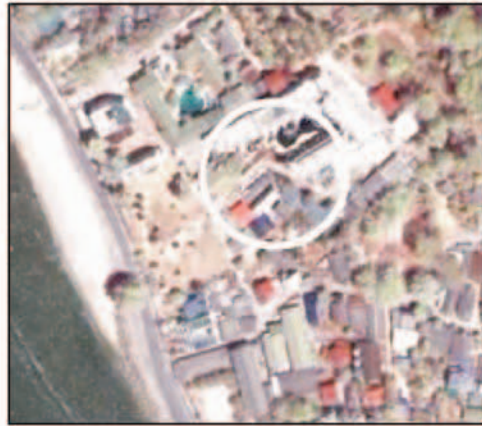
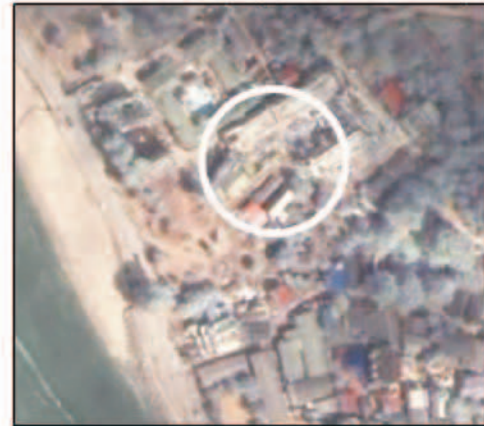
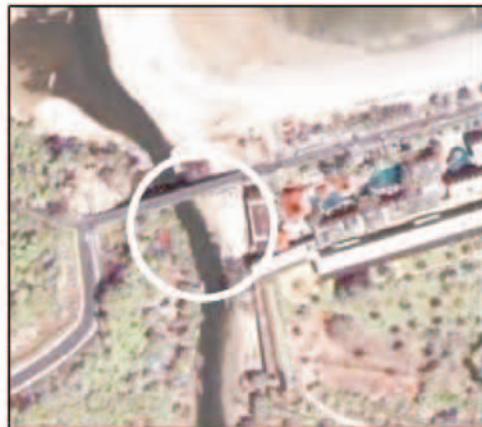
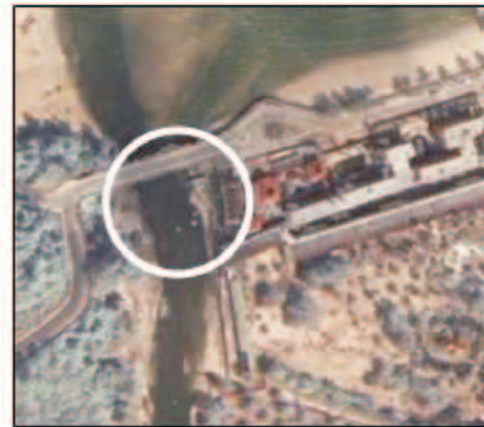
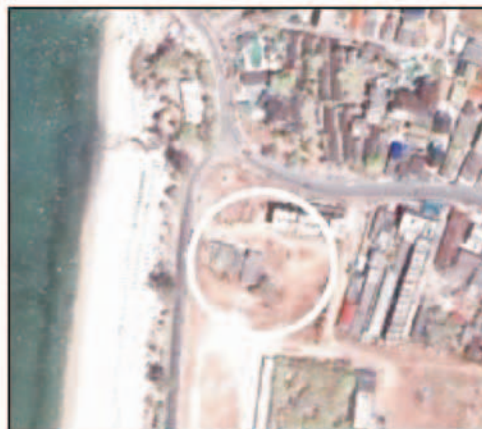
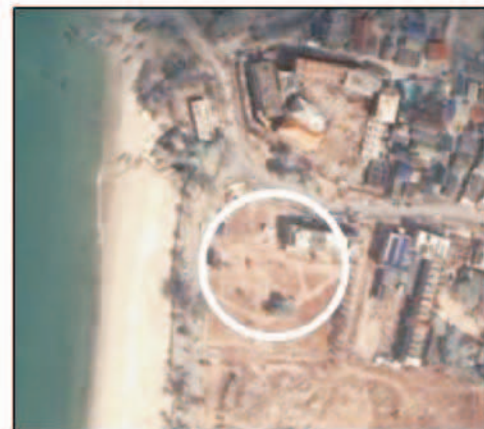
Figure 9 (continued). Selected examples of pre-event and post-event satellite imagery for Phuket: (d) Debris evident in hotel complex; (e) Changes in beach and stream configuration in after image; (f) Major change in urban development (it is difficult to infer whether this is due to tsunami damage or cleared for urban re-development due to the large difference in acquisition date between “before” and “after” images).

- Debris evident in hotel complexes in coastal areas [see Figure 9(d)]
- Change in beach and stream configuration [see Figure 9(e)].

- Wash-over of sea water has filled swimming pools and other water bodies in many areas. These look murky green rather than blue [see Figure 9(a)].
- A pier in the “before” imagery has been washed away in “after” imagery [see Figure 9(a)].
- Wash-over of sand has caused a change in road color from grey to brown [see Figure 9(b), 9(c), 9(d)].
- Beach front damage to hotel units. Some are completely destroyed. [see Figure 9(b)].
- Major change in urban development. In some cases, it is difficult to infer whether this is due to tsunami damage or cleared for urban re-development due to the large difference in the acquisition date between “before” and “after” images [see Figure 9(c) and 9(f)].
