INSTITUTE FOR SOCIAL AND ENVIRONMENTAL TRANSITION-INTERNATIONAL  
**CLIMATE RESILIENCE CASE STUDY**

## Can Tho, Vietnam

### CO-MANAGEMENT OF RIVERBANK EROSION CONTROL IN CAN THO

2013 –2016 | **Implementing Partner:** Can Tho Climate Change Coordination Office (CCCCO Can Tho)

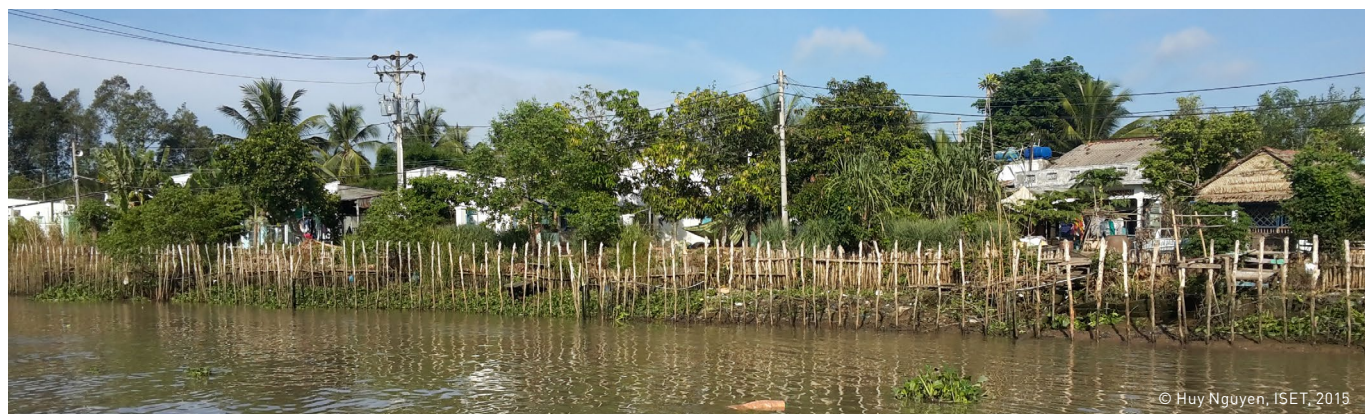
FIGURE 3

BIOLOGICAL EMBANKMENT OF CAI SON RIVER

The construction of the biological erosion control measures took only two months and was completed by September 30th 2014. The total length of biological embankment is 3,086 m along both sides of the riverbank, which is about *twice the originally planned length*. The length of riverbank protection was able to be increased due to lower than expected costs for the *Malaleuca* poles, and because of community contributions (980 person-days of labour and VND 170 million or roughly USD \$7,700 in cash). The communities along both sides of Cai Son developed a collective regulation for riverbank management that was approved by An Binh ward. The key message shared with households in the community is “**my riverbank, my responsibility**”.

After two flood seasons in 2014 and 2015, there has been no erosion damage so local men and women are very happy with the results of the project in protecting their property and their shared access roads to the community.
