Keeping Schools Safe in Earthquakes

KEEPING SCHOOLS SAFE IN EARTHQUAKES

Proceedings of the *ad hoc* Experts' Group Meeting
on Earthquake Safety in Schools, Paris, 9 to 11 February 2004

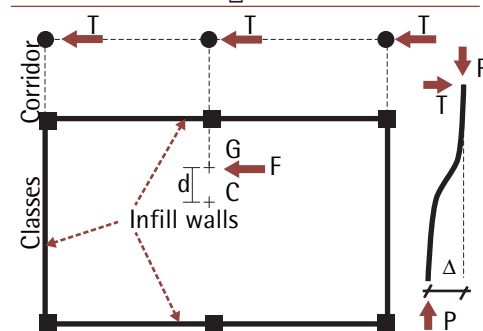
Figure 1.1. Illustration of torsional forces and P-Δ effects

to be controlled to avoid instability of the frame due to large deformations (so-called P-Δ effects) (Figure 1.1). Stringent quality control is required during construction to ensure that the design details are well-implemented in the field. Hence, the reinforced-concrete frame system requires a level of sophistication in design and construction that is typically beyond the standard practice in Algeria, and in many other developing countries.

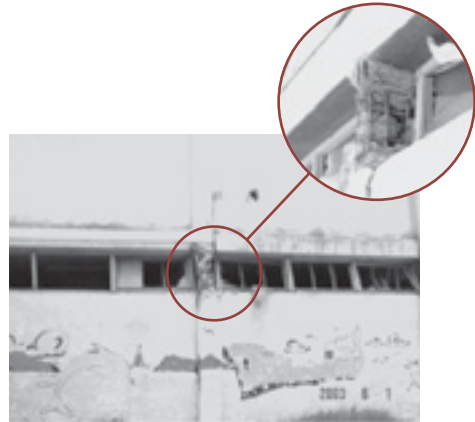
Figure 1.2. Concrete cracking on short column along back wall

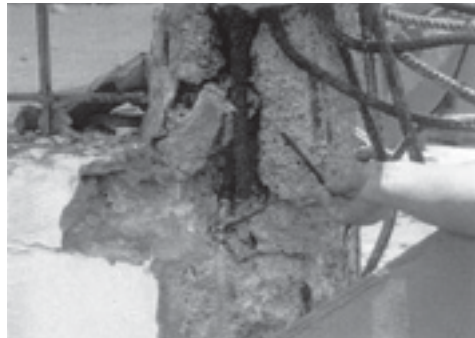
Figure 1.3. Failure of columns at joint

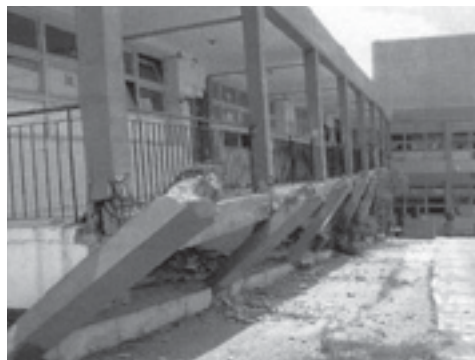
Figure 1.4. Collapse of first floor due to column failure

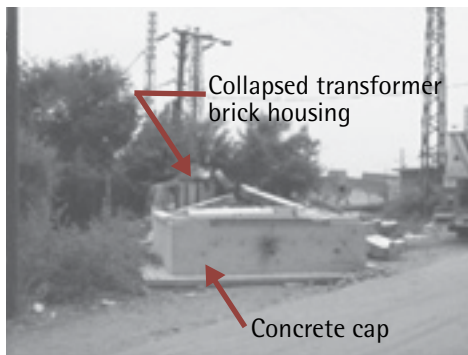
Figure 1.5. Concrete cap thrown from its original location

region exceeded 100% of gravity. As shown in Figure 1.5, the concrete cap of this transformer housing was overturned and thrown about 2 m from its location, indicating that both the vertical and horizontal motion exceeded 100% of gravity. Hence, the underestimation of the ground motion input in the code consistently results in school structures with lower earthquake capacities than the potential demands from earthquakes. Even under the best circumstances – *i.e.* good concept, good design and good construction – this underestimation translates into high vulnerability.

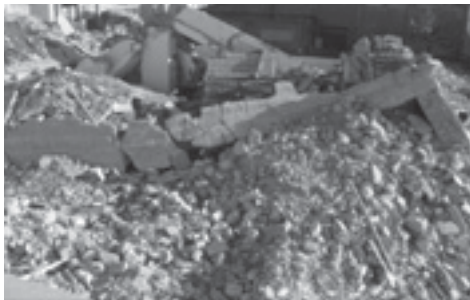
Figure 3.1. Rubble stones, reinforced-concrete kerb in the ruins of the San Giuliano primary school

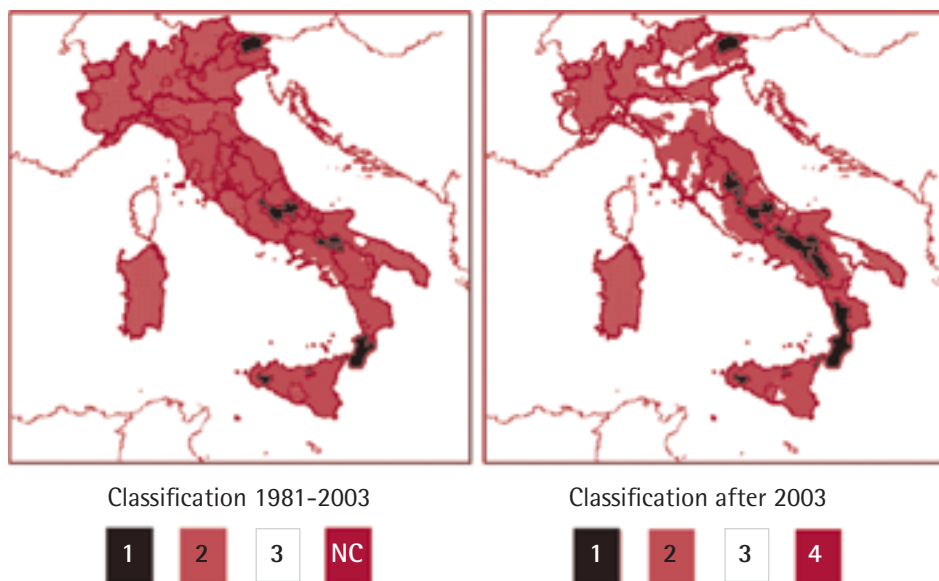
Figure 3.2. Seismic classification of the Italian territory

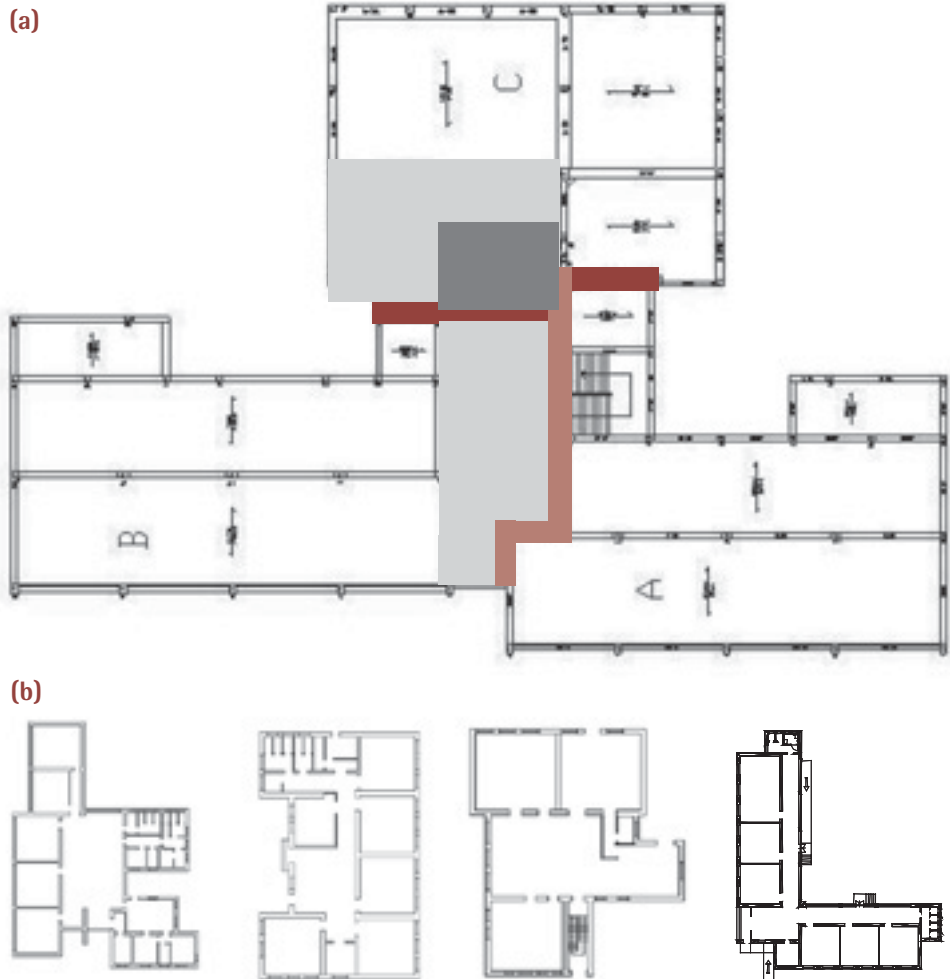
- (a) Structural layout of a reinforced-concrete multi-storey school at Campobasso
 (b) Layout of three single-storey schools with masonry structures

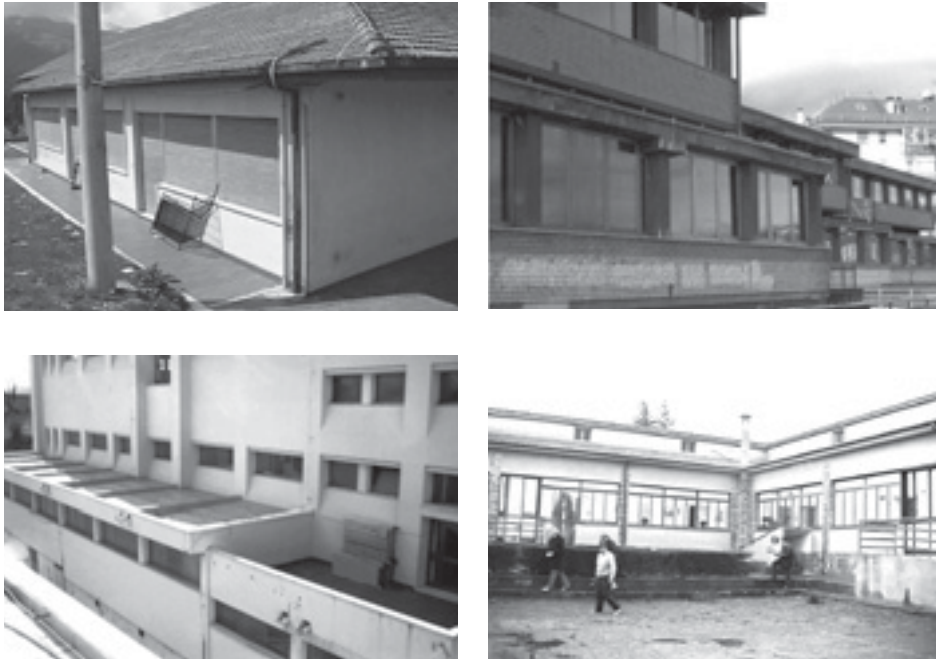
and in elevation (soft storey), creating local weaknesses and unaffordable ductility demand. The excessive inter-storey height, commonly seen in gymnasium and theatre structures, increases the flexibility of the structure and the danger of collapse of infill panels in reinforced-concrete structures in low intensity earthquakes. Figure 3.3 presents the planimetric layout of a reinforced-concrete multi-storey school and masonry single-storey school, showing the plan irregularity, the wide windows and the large span that is characteristic of school buildings. Figure 3.4 provides an example of schools with wide openings and large inter-storey height.

Figure 3.4. Wide windows, large inter-storey drift, irregular shapes of single- and multi-storey schools

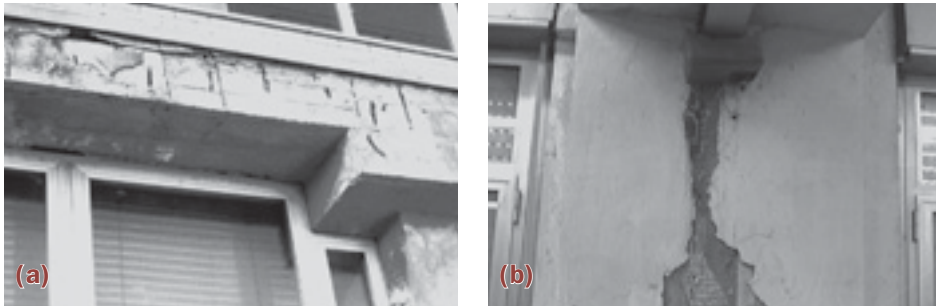
**Figure 3.5. (a) Deterioration due to no maintenance
(b) Inadequateness of separation joints**

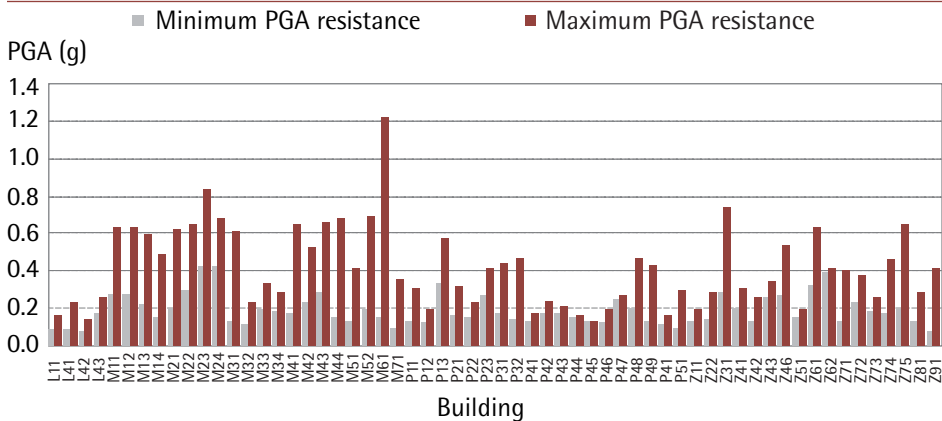
**Figure 3.6. Reinforced-concrete buildings:
Minimum PGA resistance at the various storeys and in X and Y directions**

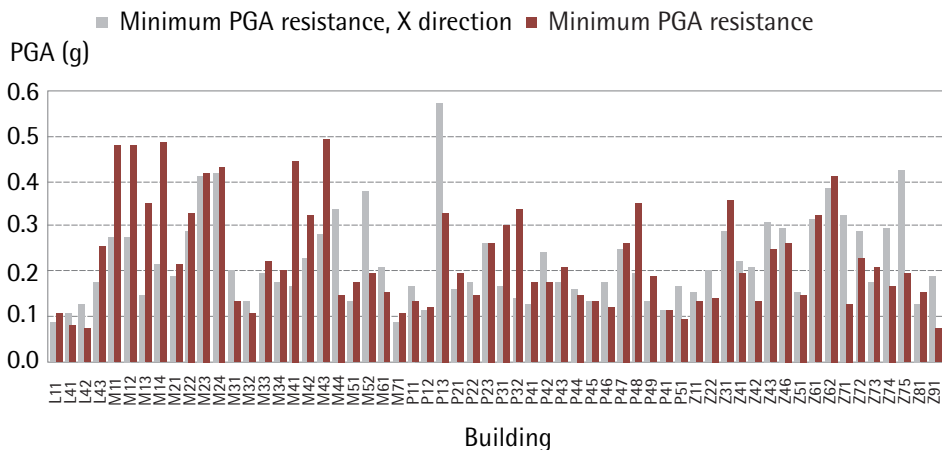
**Figure 3.7. Reinforced-concrete buildings:
Minimum PGA resistance in the X and Y directions**

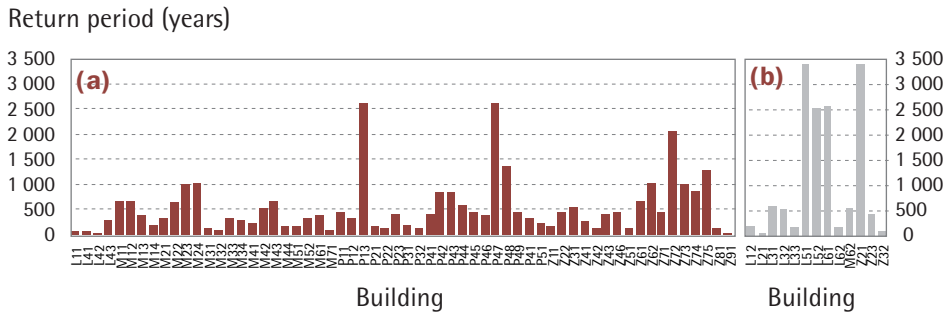
Figure 3.10. Return period of the collapse earthquake of (a) reinforced-concrete and (b) masonry buildings

- Concerning *seismic risk*, nine buildings have a return period of less than 100 years, which means a 10% probability of occurrence in ten years; 26 schools have a return period of less than 200 years; and for 28 buildings, the return period of collapse in an earthquake is more than 500 years.

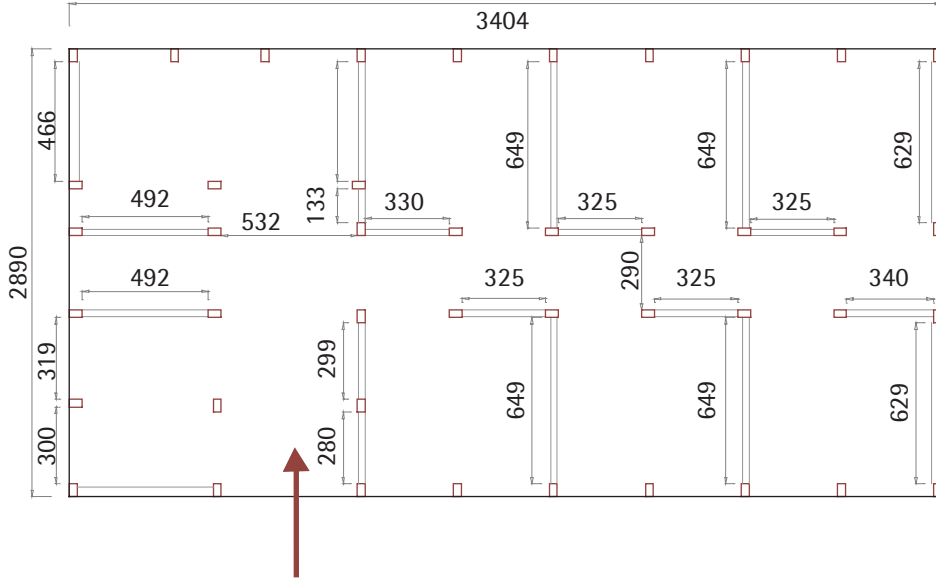
All walls shown in the drawing occupied a full span. Walls with openings are excluded. All columns have dimensions of 0.3 m x 0.5 m. The arrow indicates the entrance to the building (dimensions are in cm).

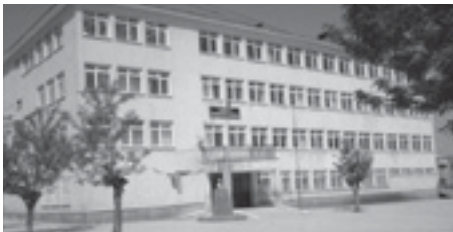
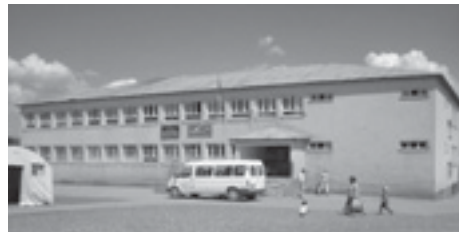
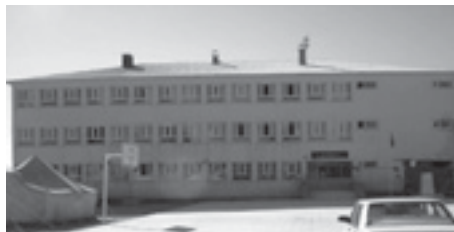
Figure A4.3. School buildings with a typical floor plan

Column dimensions are the same irrespective of the number of floors.

C-13-02 was the only school building with a different column layout. The school complex was a combination of two separate buildings. The separation afforded by the expansion joint between the two buildings was not sufficient to avoid pounding between the two structures. The floor plan of the northern building is shown in Figure A4.4. All columns shown in the figure have dimensions of 0.2 m x 0.5 m.

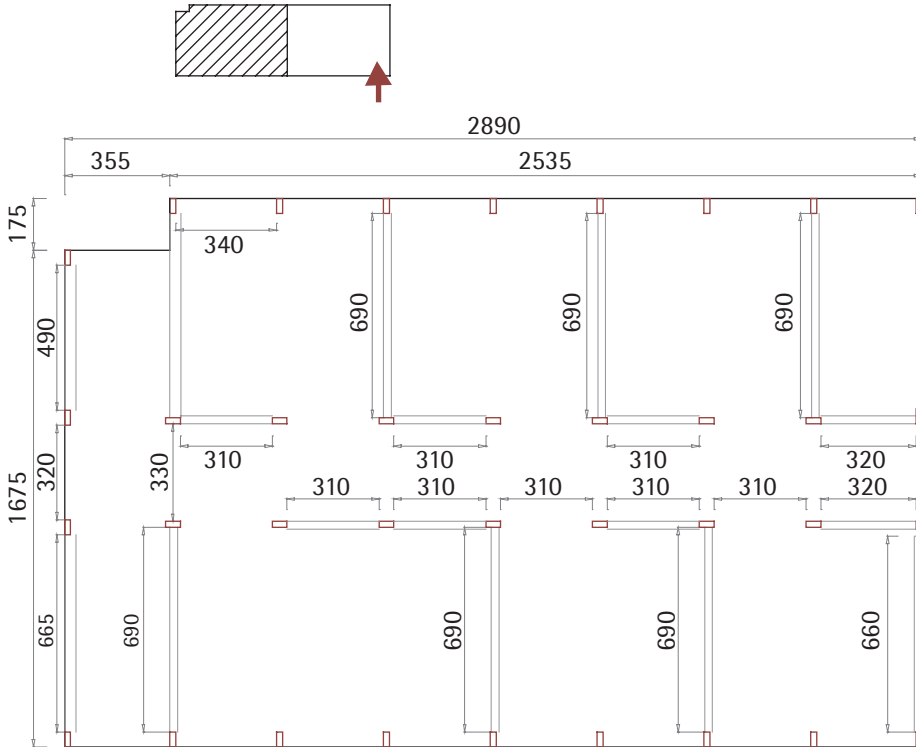
The structural system is a moment-resisting frame. The columns are 0.2 m x 0.5 m. The school building comprises two independent structures separated by an insufficient expansion joint. Only the shaded area of the upper figure was surveyed. The arrow indicates the entrance to the building (dimensions are in cm).

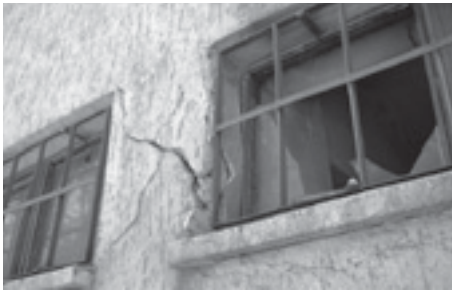
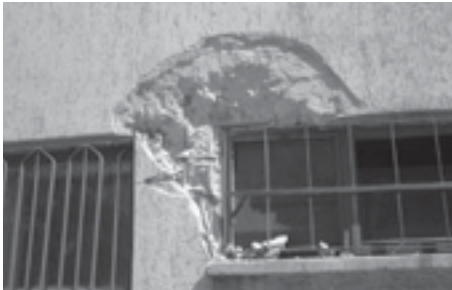
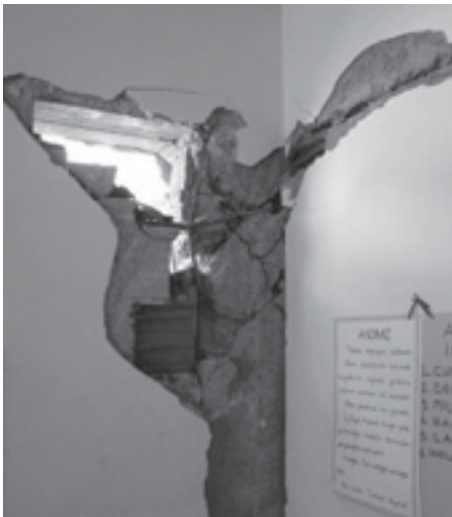
Figure A4.5. Shear failure of captive columns created by the small windows of the furnace room in building C-14-03

In all school buildings surveyed, the detailing of structural members was inadequate with respect to requirements of modern seismic codes. Lack of confinement in plastic hinge regions of the columns was observed to be one of the most significant causes of damage. Although the spacing of the stirrups was reduced in the end regions of some columns, the amount of transverse reinforcement provided was not sufficient to prevent shear failures, particularly in the case of captive columns (Figure A4.6). Another commonly observed detailing deficiency was the inadequate anchorage of the free ends of the stirrup reinforcement (Figure A4.7).

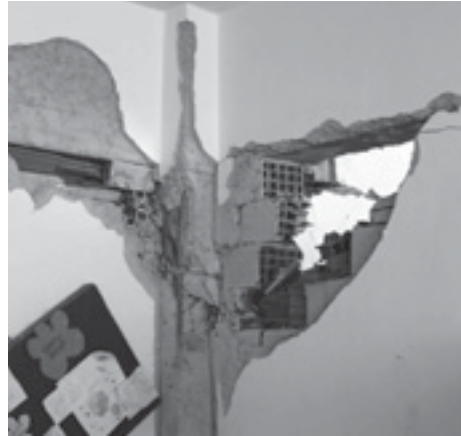
Figure A4.6. Shear failure of captive columns as a result of upper corner of masonry walls' crushing in building C-14-01

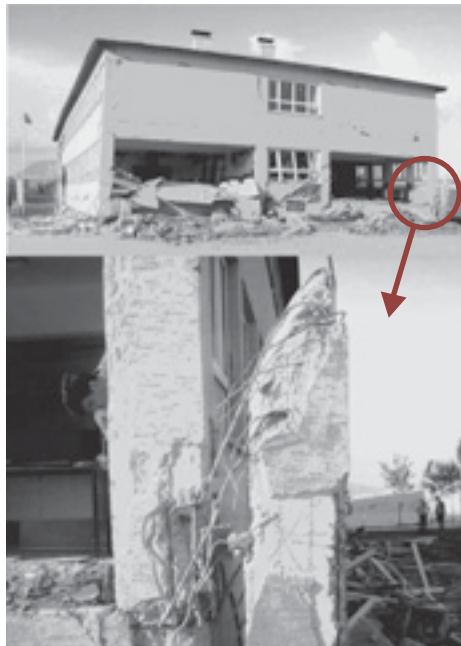
Figure A4.7. Typical confinement detail of a column in building C-13-09

The shear failure in the columns initiated the collapse of the first floor. The spacing of the transverse reinforcement was 10 cm at the top 30 cm portion of the columns. The ends of the stirrups were not anchored properly.

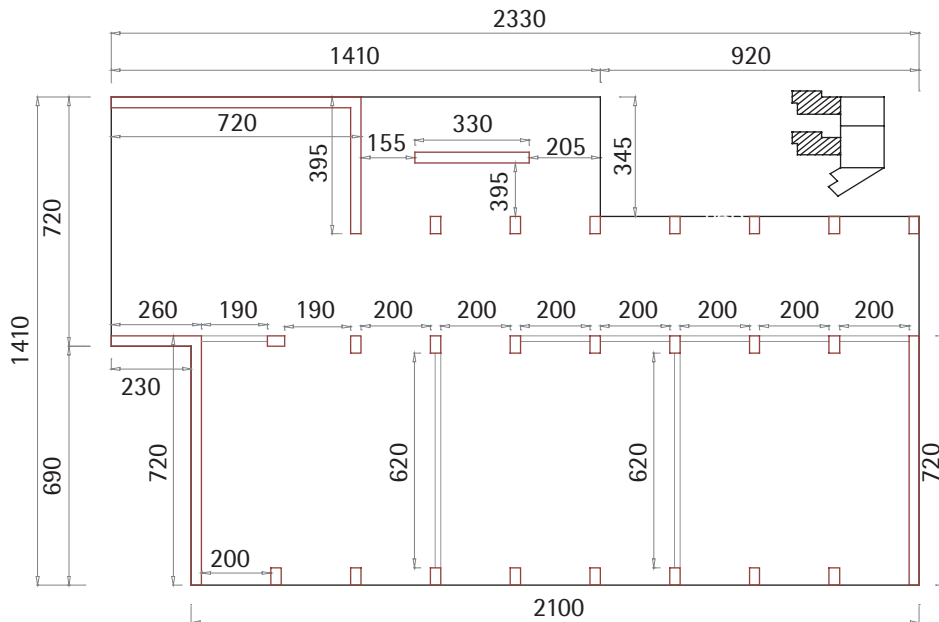
All columns have dimensions of 0.3 m x 0.5 m. The thickness of the reinforced concrete and masonry walls was 0.30 m and 0.16 m, respectively (dimensions are in cm).

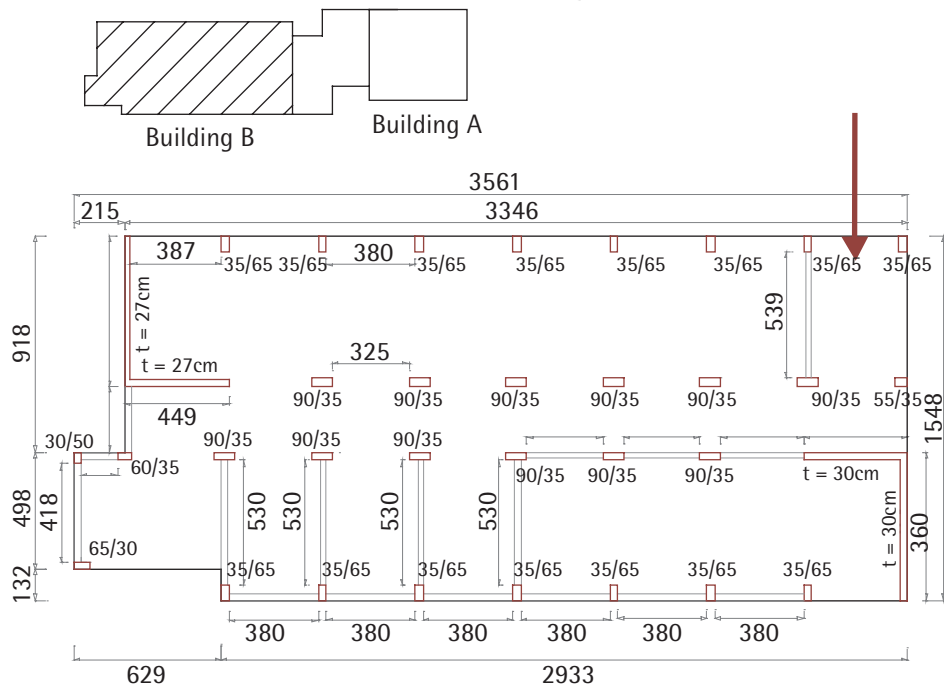
The thickness of interior and exterior masonry walls was 0.25 m and 0.30 m, respectively. The arrow indicates the entrance to the building (dimensions are in cm).

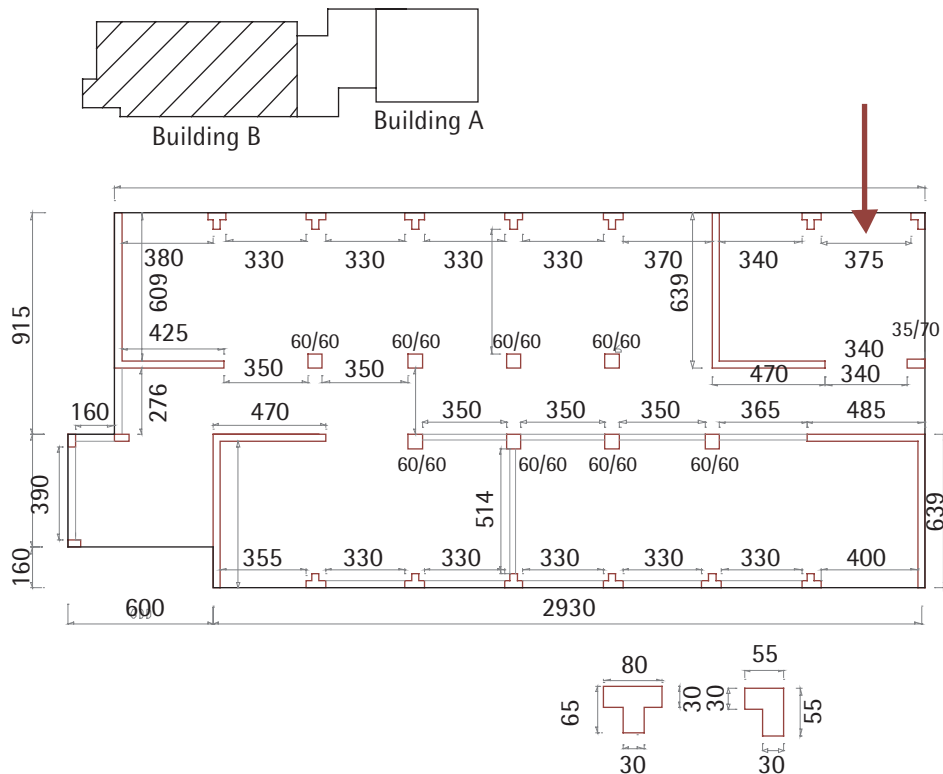
The thickness of the shear walls was 0.3 m. The masonry wall thickness was 0.25 m for the interior walls and 0.3 m for the exterior walls. The arrow indicates the entrance to the building (dimensions are in cm).

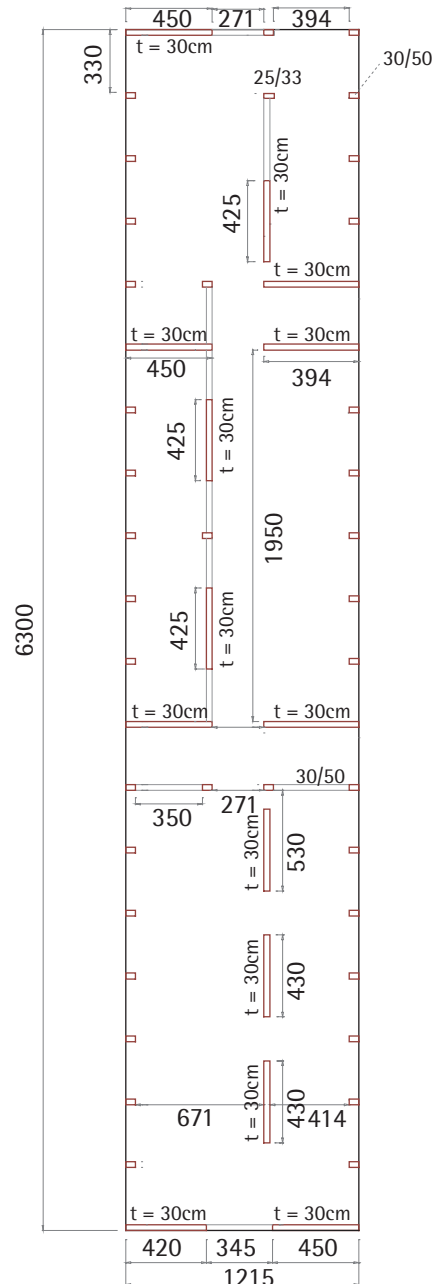
The masonry wall thickness was 0.3 m (dimensions are in cm)

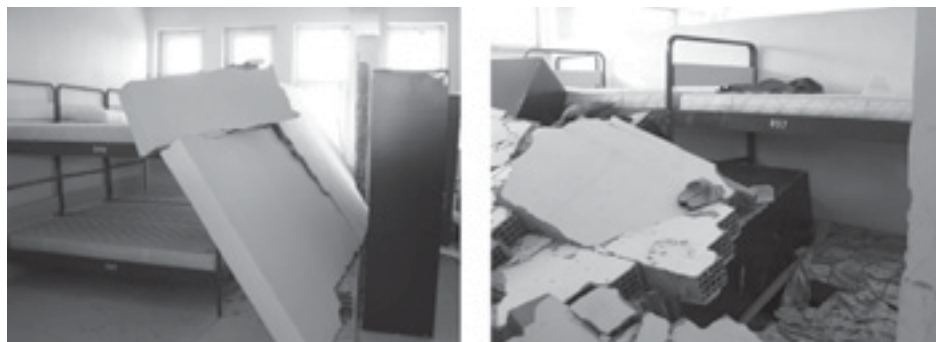
Figure A4.12. Collapse of free-standing masonry walls onto beds in dormitory buildings

masonry walls separating the sleeping units in the upper levels. These walls were not included in the damage rating because they were not attached to the structural system. However, these walls presented a serious hazard to the students living in the dormitories because in some cases the walls collapsed on the beds (Figure A4.12).

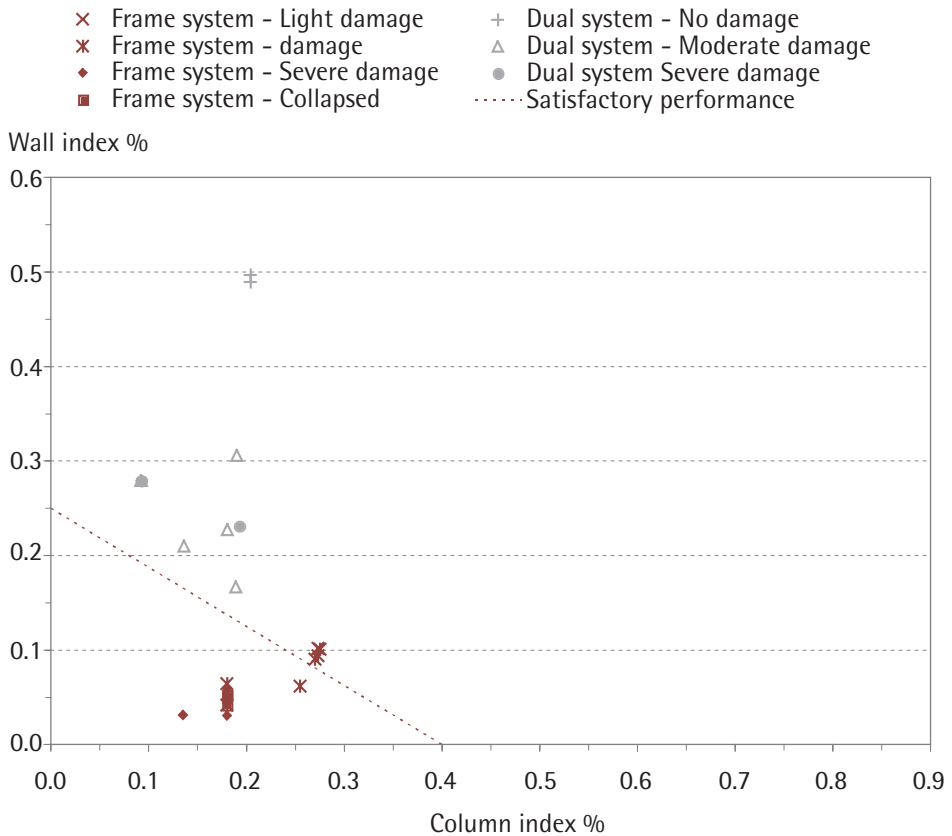
Figure A4.13. Correlation between structural performance and wall and column indices in schools and dormitories

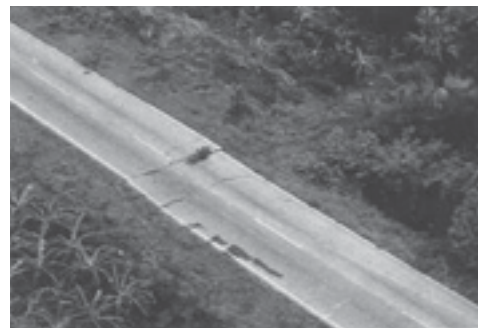
Figure 5.2. Right-lateral strike-slip fault

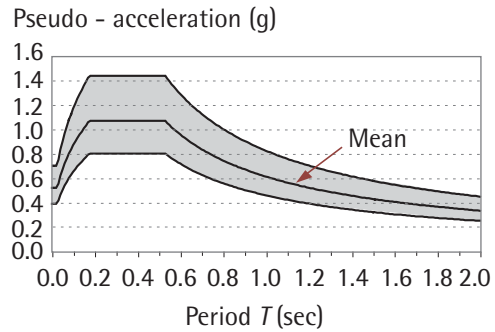
Figure 5.3. Pseudo-acceleration response spectrum

The soil at the sites of the two school buildings in Cariaco consists of pre-dominantly fine materials with similar characteristics throughout the soil column: very soft for the first 10 m, moderately dense between the depths of 10 m and 20 m, and dense or very dense at a depth of more than 20 m. Using attenuation laws for near-fault motions recorded on soil (Abrahamson and Silva, 1997; Boore, Joyner and Fumal, 1997; Campbell, 1997; Sadigh *et al.*, 1997), the median of the PGA was associated with a probability of exceedence of 50% (Table 5.1). Averaging for all the laws, the median PGA was 0.52 g, with a 50% probability of being between 0.39 g and 0.70 g. The pseudo-acceleration response spectrum was determined using the smooth spectrum built from the mean spectrum of a collection of 38 near-fault motions recorded on soil, for 5% damping (López *et al.*, 2004). Figure 5.3 shows the resulting mean, upper and lower smoothed spectra, which define a range of pseudo-acceleration values with a probability of occurrence of about 50%.

Demand was estimated based on the dynamic elastic response to the pseudo-acceleration spectrum (Figure 5.3) applied in the direction of the collapse. With a total weight of 42 t, the fundamental period for the structure is 0.65 s. A base shear demand between 254 t and 456 t with a 50% probability of occurrence was obtained. Displacement demand corresponds to drifts between 15% and 27% in both storeys (Figure 5.6(b)). This demand is between eight and 15 times greater than the capacity of the structure, which creates an intolerable ductility demand, especially for a structure with very low energy-dissipation capacity.

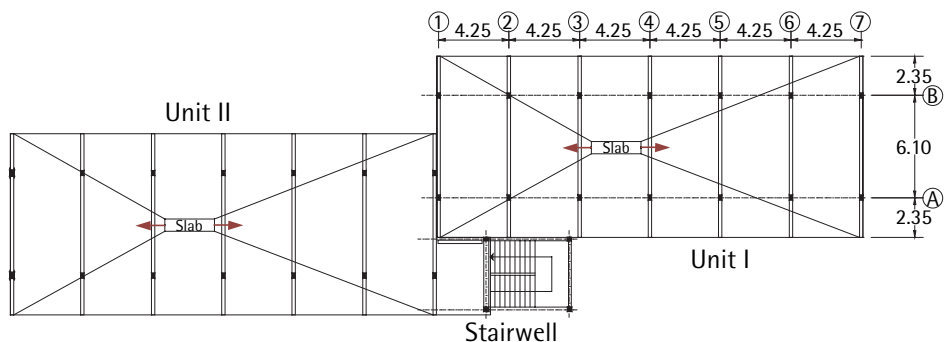
Figure 5.4. Structural plan at first storey of Valentín Valiente School (dimensions in metres)

The building had very low energy-dissipation capacity due to the small amount of transversal reinforcement and the short columns. Furthermore, the building was weak in the longitudinal direction due to the lack of beams and the small size of the columns. The collapse of both modules during the earthquake was similar – five people were killed – with great displacement along the longitudinal direction (Figure 5.5(b)). When the columns on both floors failed, the slabs were left resting on the walls. Brittle failures were observed in the short columns, and ductile failures were seen in the long columns.

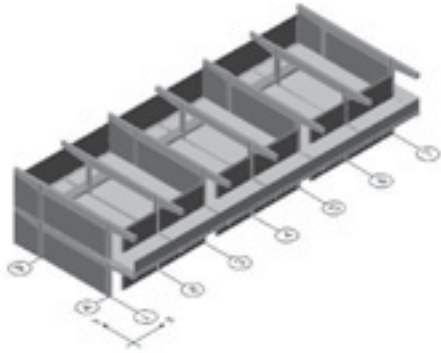
Figure 5.5. Three-dimensional view of Valentín Valiente School and structural collapse

(a) Three-dimensional view of Valentín Valiente School showing frames and infill walls

The Valentín Valiente School (VV), built in 1958, consisted of two independent modules (Figure 5.4). Each module had two storeys and was rectangular in shape, with a reinforced-concrete structure and masonry infill made of 15 cm-thick hollow concrete blocks connected to the frames (Fernández, 1998; IMME, 1998). The concrete joist floor system had a 5 cm slab with joists spaced 50 cm apart in the longitudinal direction, and all columns had a 20 cm x 30 cm section. Frames with deep beams (20 cm x 65 cm) were located along the transversal direction of the building, but there were no beams along the longitudinal direction. Materials tests performed after the earthquake showed a concrete strength in compression of 140 kgf/cm²; the minimum yield stress for the bars is 2 400 kgf/cm². No transversal reinforcement was placed in the joints. The transversal reinforcement in beams and columns consisted of plain bars Ø 1/4" hoops set 25 cm and 15 cm apart, respectively (Bonilla *et al.*, 2000; Fernández, 1998). Two types of masonry infill were used (Figure 5.5(a)): some were 2.25 m high and completely filled the transversal frames along axes 1, 3, 5 and 7; others were 1.70 m high and generated short columns with 55 cm clear length on longitudinal frame A. Longitudinal frame B had a very rigid reinforced-concrete bench stiffly connecting the columns at a height of 50 cm from the floor.

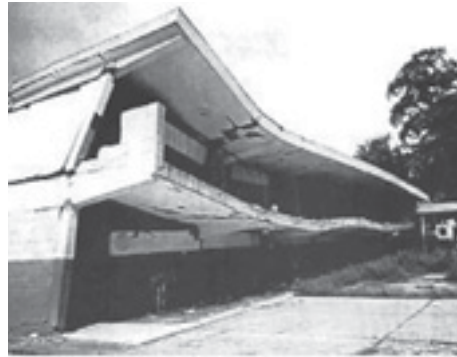
(b) Structural collapse in longitudinal direction of Valentín Valiente School (Bonilla et al., 2000)

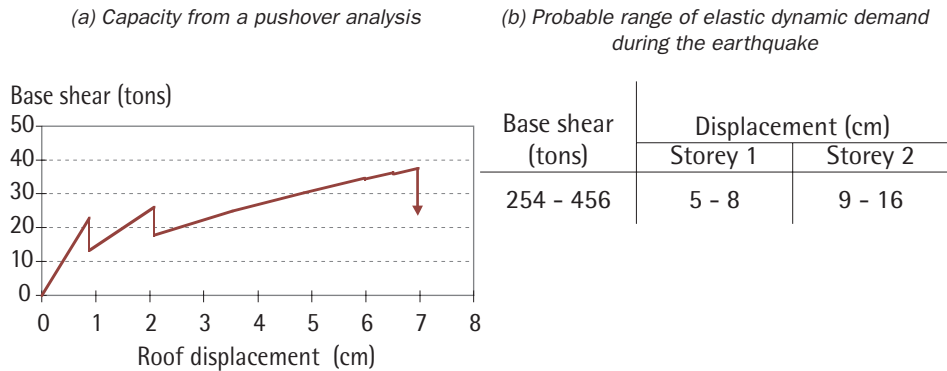
Figure 5.6. Capacity and demand in longitudinal direction of Valentín Valiente School

The building's capacity was determined by means of a non-linear static (pushover) analysis; lateral triangular loads were applied in the longitudinal direction until the structure became unstable. The masonry infill was modelled by diagonal compression struts. The slab concrete joists were modelled by equivalent beams. Figure 5.6(a) shows the base shear against the roof displacement. The results indicated a first shear failure in the short columns A2, A4 and A6 of the first storey (Figure 5.4), for a base shear of 23 t; followed by a second shear failure in the same three columns on the second storey, for a base shear value of 26 t; and subsequent bending failures of the joists and of the other columns, up to 36 t, for a roof displacement of 7 cm. In order to estimate the risk index, a value of 30 t was given as the ultimate capacity of the structure.

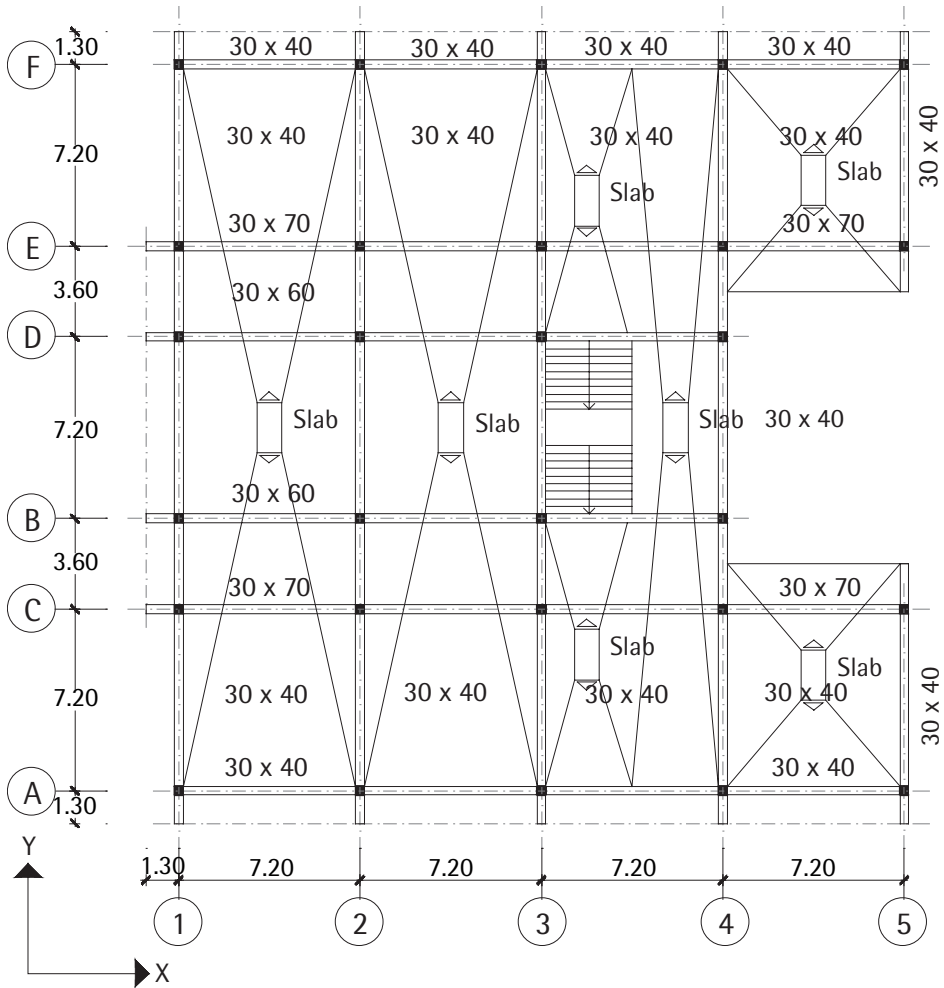
Figure 5.7. Structural plan at first storey of one unit of RMC school (in metres)

Raimundo Martínez Centeno High School (RMC) in Cariaco was built in 1985, although the structural drawings are dated 6 April 1978. The blueprints indicated that the structure had been designed for Seismic Zone 2, following the 1967 standards in force at the time. According to those standards, Cariaco was located in Seismic Zone 3, where seismic requirements were two times greater than those for Zone 2. The school consisted of two similar, independent modules, with a C-shaped floor plan. One module had three storeys, and an additional floor had been added in a small area of the other module. Only the three-storey module, the floor plan for which is shown in Figure 5.7, was analysed. Each unit had a reinforced-concrete structure with frames in both horizontal directions and 15 cm thick masonry infill (Figure 5.8(a)). The total thickness of the concrete joist floor system was 30 cm, with ribs in the Y direction (Figure 5.7). The columns measured 35 cm x 35 cm.

The beams in the Y direction had a 30 cm x 40 cm section. In the X direction, the beams were 30 cm wide and between 40 cm and 70 cm high. The masonry infill in frames 1 to 5 completely filled the frames. In frames B and E, the masonry infill created short columns with a length of 70 cm. In frames A and F, the length of the short column was 170 cm. The first storey only had one-third the number of walls filling the frames as on the second storey, and half the number of those on the top storey. Tests performed after the earthquake showed a concrete strength of about 250 kgf/cm², and 4 200 kgf/cm² for the yield stress of the reinforcing bars (IMME, 1998), which was consistent with the values specified in the design. Columns hoops of Ø 3/8" were installed 10 cm apart near the

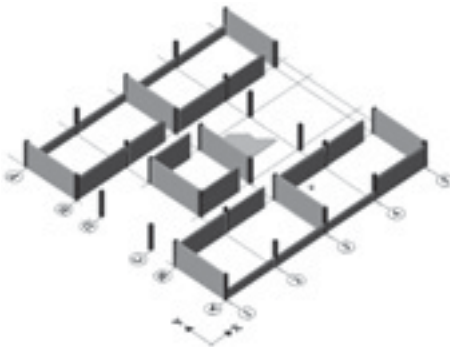
Figure 5.8. Three-dimensional view of RMC school and structural collapse

(a) Three-dimensional view of RMC school showing infill walls in first storey

The school had very low energy-dissipation capacity; the columns were weaker than the beams and had little shear strength. The masonry infill was connected to the columns, creating short columns with a potential brittle failure mode. In addition, there was a significantly higher number of masonry infill on the upper storeys compared to the ground floor, creating a weak and soft first storey. Both modules exhibited similar behaviour during the earthquake, consisting of failure of the columns on the lower level and collapse of the building – causing 18 deaths – with displacement predominantly in direction X, leaving the second storey resting directly on the ground (Figure 5.8(b)). There were no signs of collision between the two modules. On the second and third storeys that were left standing, shear failures were noted in several of the short columns, and compression and buckling of the longitudinal steel was seen in others (Castilla and Marinilli, 2000; IMME, 1998).

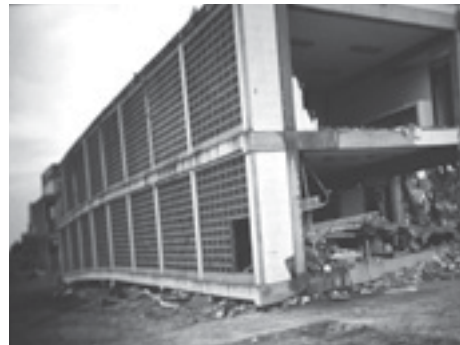
(b) Collapse of first storey of RMC school (Photo courtesy of E. Castilla)

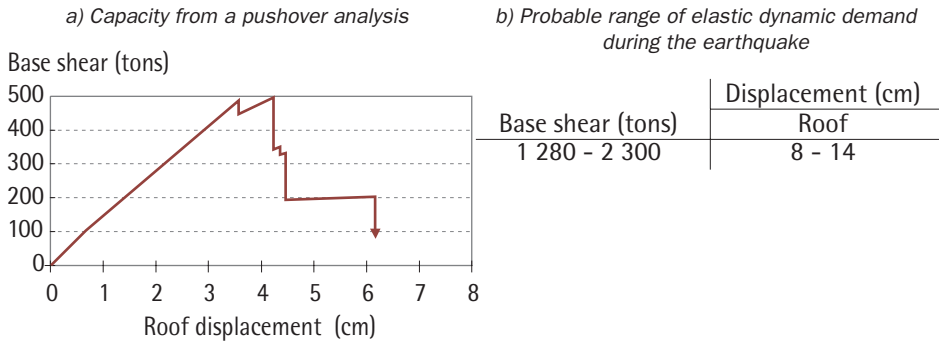
Figure 5.9. Capacity and demand of RMC school in the X direction in Cariaco

The lateral capacity of the building in the direction of the collapse X was determined using a pushover analysis. The masonry infill was modelled using diagonal struts. The building had a fundamental mode period equal to 0.58 s in direction X and a weight of 1 900 t. The shear force at the base vs. displacement at the roof is shown in Figure 5.9(a). The results indicated a shear failure in short columns B3 and E3 on the first storey, for a load of 477 t; followed by a shear failure of the other short columns B1, E1 and A4 to 487 t; and, subsequently, shear failure of several long columns. A value of 450 t was taken as the ultimate capacity of the building. The demand brought about by seismic motion (Figure 5.3) was determined by means of a dynamic elastic analysis (Figure 5.9(b)). This demand was between 2.8 and 5.1 times greater than capacity, which is considered excessive given the low energy-dissipation capacity of the structure.

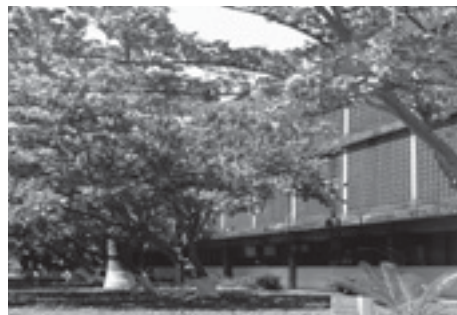
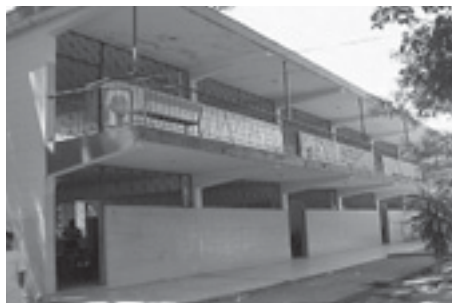
a) Identical to RMC (Figure 5.8(b))
(Photo courtesy of E. Castilla)

b) Identical to V V (Figure 5.5(b))

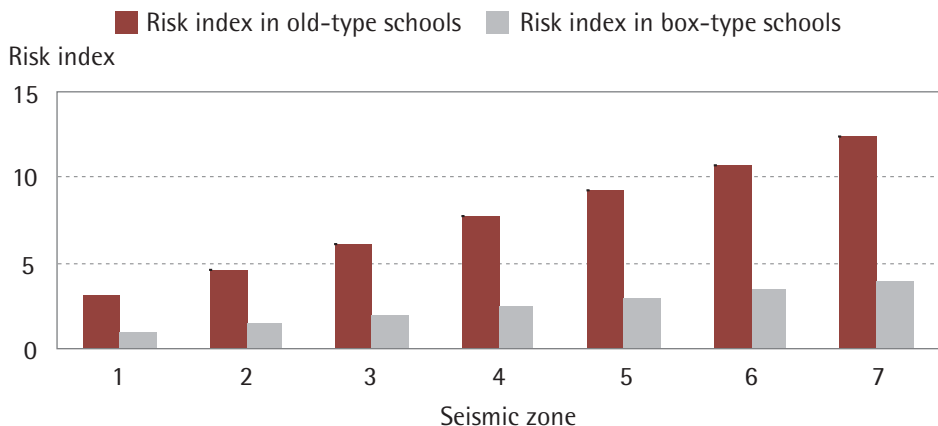
Figure 5.11. Risk index of standard school types in seismic zones in Venezuela

The risk indices, RI, were determined at the local and global levels. At the local level, the RI is the quotient of force-demand and capacity in a given structural element. In elements with ductile failure modes, this index is an approximation of local ductile demand. At the global level, the RI is the quotient of the base shear demand and capacity as determined by a non-linear static analysis, and the other index is the quotient of drift demand and admissible drift according to the code. Selected results for the RI of the base shear for the model with walls and stairs and concrete strength of 200 kgf/cm² are presented in Figure 5.11. The characteristics and detailing of elements and joints do not allow for indices of more than 2.

The results presented in Figure 5.11 show unacceptable risk levels for the old-type school, even in low seismic zones, indicating an urgent need for retrofitting. Results also suggest that only those box-type schools located in high seismic risk zones need to be retrofitted.

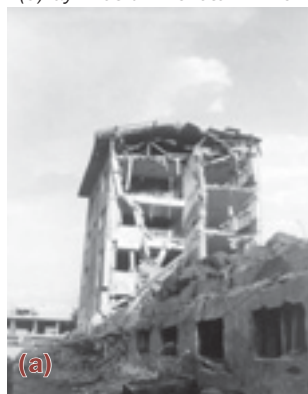
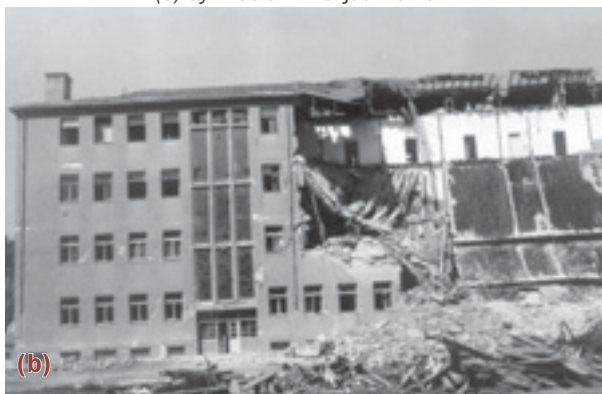
Figure 6.1. Partial collapse of secondary schools in the 26 July 1963 Skopje earthquake

(a) *Gymnasium “Cvetan Dimov”*

(b) *Gymnasium “Zefljus Marko”*

In the Skopje earthquake of 1963 (Table 6.3), 44 urban school buildings – or 57% of the total urban school building stock, providing education for about 50 000 children – were destroyed. Fortunately, the Skopje earthquake occurred during the summer holidays, at 5:17 a.m. local time, when school buildings were not being used. Thus, there were no human casualties associated with the heavy school building loss. Nevertheless, schooling was heavily interrupted both in Skopje and throughout the entire country. Most children were evacuated until school buildings were repaired and strengthened and/or new temporary or permanent school facilities were erected. Unfortunately, neither the government nor schools had prepared emergency plans for such a situation. As in many other cases, if the earthquake had occurred while students were in the school building, the Skopje casualty figures would have been enormous (Figure 6.1).

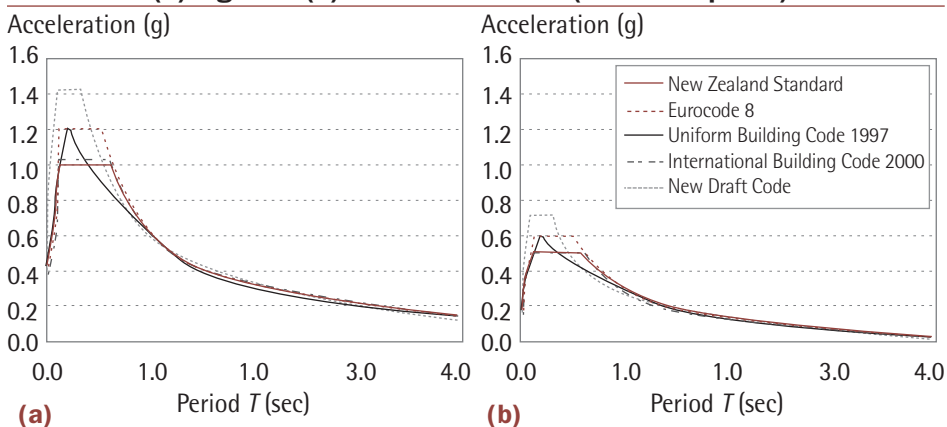
The seismic design provisions in the New Zealand standards are generally comparable to international standards, such as the Uniform Building Code 97 (ICC, 1997), Eurocode 8 (BSI, 1998) and the International Building Code (BOCA and ICBO, 1998). A comparison of design spectra from these standards is shown in Figure 7.2.

Figure 7.2. Comparative design spectra for nominal 500-year return period for (a) high and (b) low seismic zones (elastic response)⁴

The New Zealand design force spectra are generally similar to those found in other standards. However, it should be noted that the design and detailing standards and the on-site construction standards are at least as important as the design forces in determining effectiveness of a building's earthquake resistance.

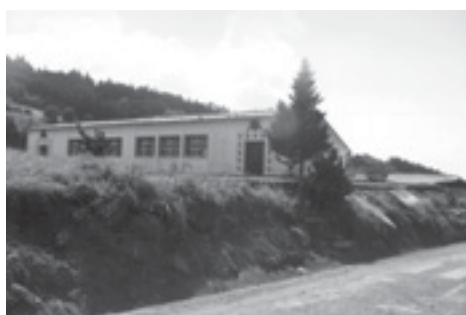
Figure 8.2 – a two classroom, one-storey, early reinforced-concrete school in Espalhafatos – shows one of the most common solutions for educational buildings. The school building design and construction is similar to that found in Salão, Capelo, Lombega and Feiteira (Rua da Portela).

Figure 8.2. Overview of school at Espalhafatos

Espalhafatos	VII	Early reinforced concrete	High	Average	1	Damage at corners with separation between masonry and reinforced-concrete elements, damage at the column bases and cracks in external walls	Cracking in partition and external walls and floor settlement	Damage in external retaining walls	Use after extensive repairs
Salão	VII	Early reinforced concrete	High	Average	1	Damage at the columns	Cracking in partition and external walls and cracking in the connection between floors and walls	Damage in external retaining walls	Use after moderate repairs
Salão (kindergarten)	VII	Masonry wall	Medium	Average	1	External wall collapse	General damage	General damage	No use, demolition
Cedros	VI	Early reinforced concrete	High	Good	2	None	Cracking in partition and external walls	Cracking in external retaining walls	Immediate use
Cascalho	V-VI	Frame reinforced concrete	High	Good	1	Slight cracking in reinforced-concrete roof beams	Slight cracking in partition walls	None	Immediate use

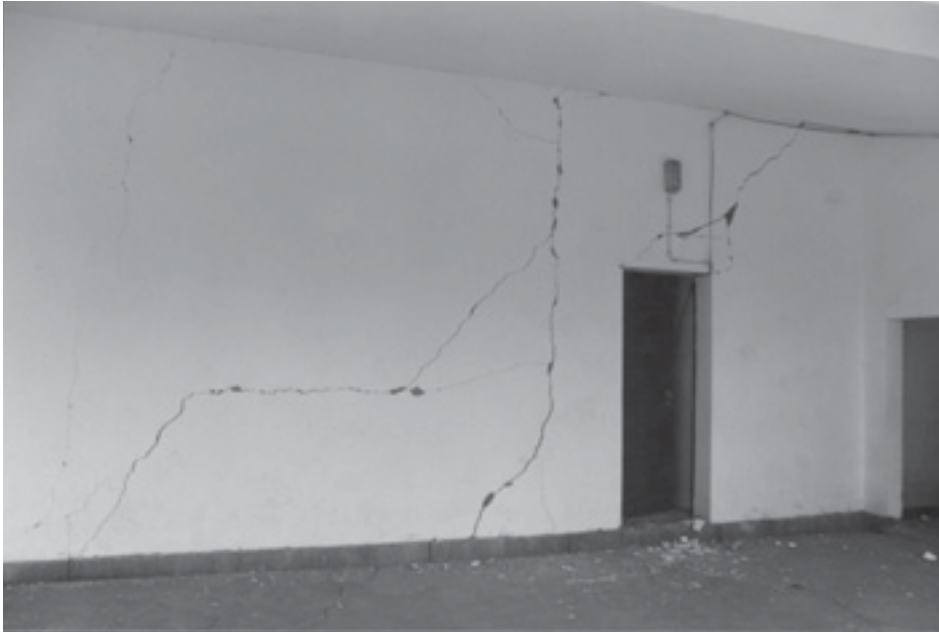
Figure 8.3. Severe cracking in internal partition walls at school in Espalhafatos

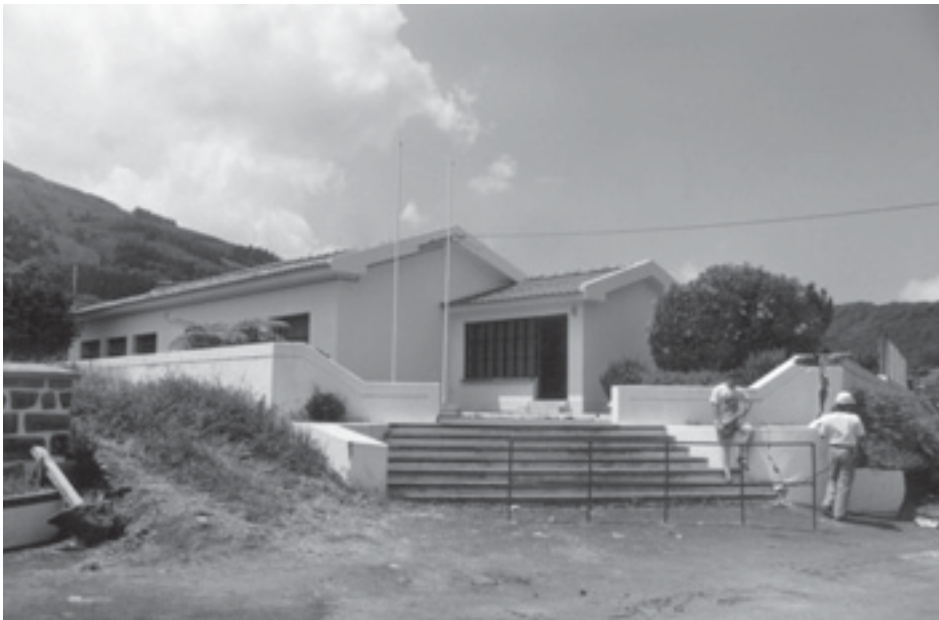
Figure 8.4. Damage in reinforced-concrete roof beams and in retaining walls at school in Ribeirinha

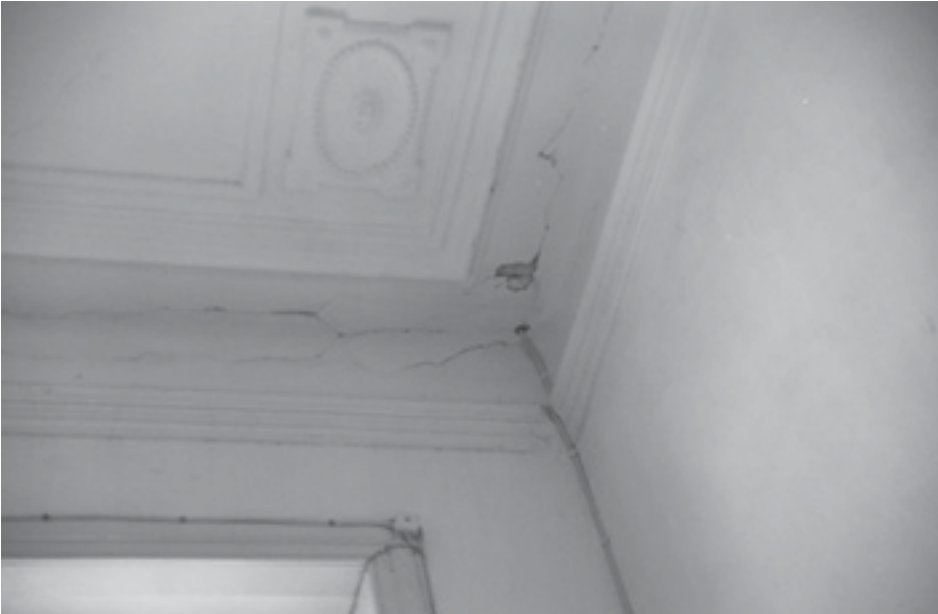
Figure 8.5. Cracking of stucco ceiling at Horta (Coronel Silva Leal) school
