Keeping Schools Safe in Earthquakes

KEEPING SCHOOLS SAFE IN EARTHQUAKES

Proceedings of the *ad hoc* Experts' Group Meeting
on Earthquake Safety in Schools, Paris, 9 to 11 February 2004

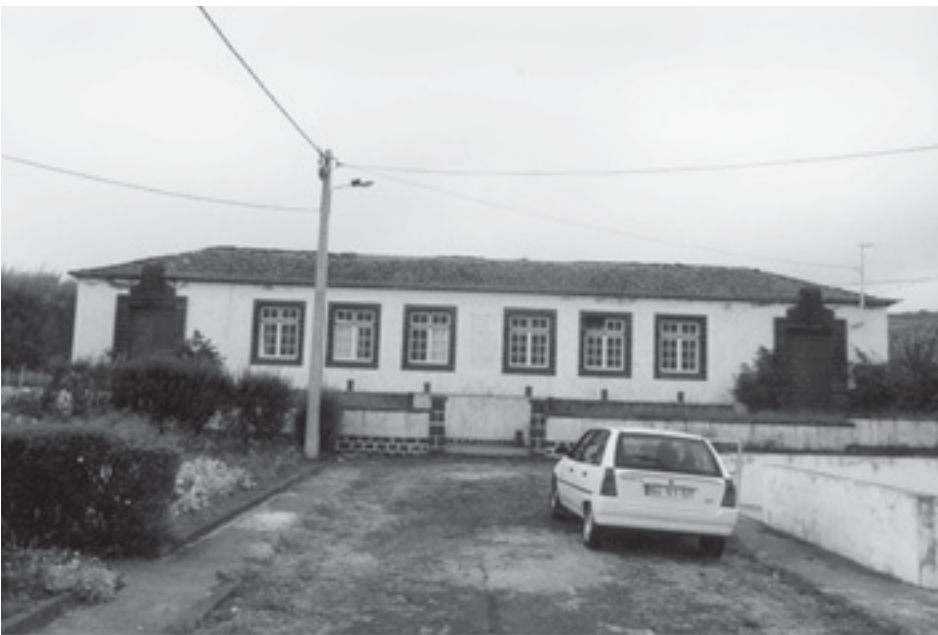
Figure 8.6. Dislocated roof tiles at Castelo Branco (Carreira) school

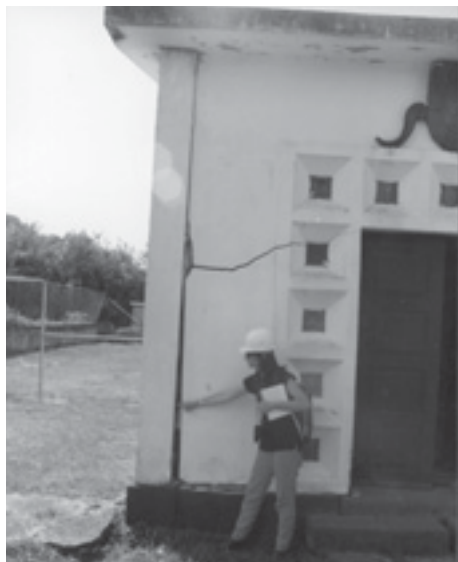
Figure 8.7. School in Espalhafatos: Separation between block masonry and reinforced-concrete elements

The extent and nature of damage in these educational buildings was strongly influenced by the structural solution. In recent reinforced-concrete structures, cracks were observed in structural elements, such as columns. Other side-effects were also noted, such as pounding and the development of short-column phenomenon resulting from partial, initial or damage-influenced restraint by adjacent non-structural masonry walls. In masonry structures, cracks of varying widths and extensions were observed in external and internal walls. Damage in early reinforced-concrete structures was similar, although less pronounced, than damage detected in masonry structures, with some signs of separation between the block masonry and reinforced-concrete discrete elements.

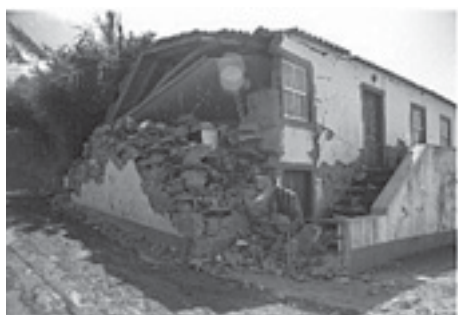
Figure 8.8. Collapse of external rubble masonry walls in kindergarten in Salão

One of the most prevalent forms of damage in the “other” category was the collapse, cracking or overturning of earth-retaining walls, generally made of rubble masonry. This was caused by the fact that the buildings were generally constructed on relatively steep slopes. Dislocated tiles were also found on a number of educational buildings.

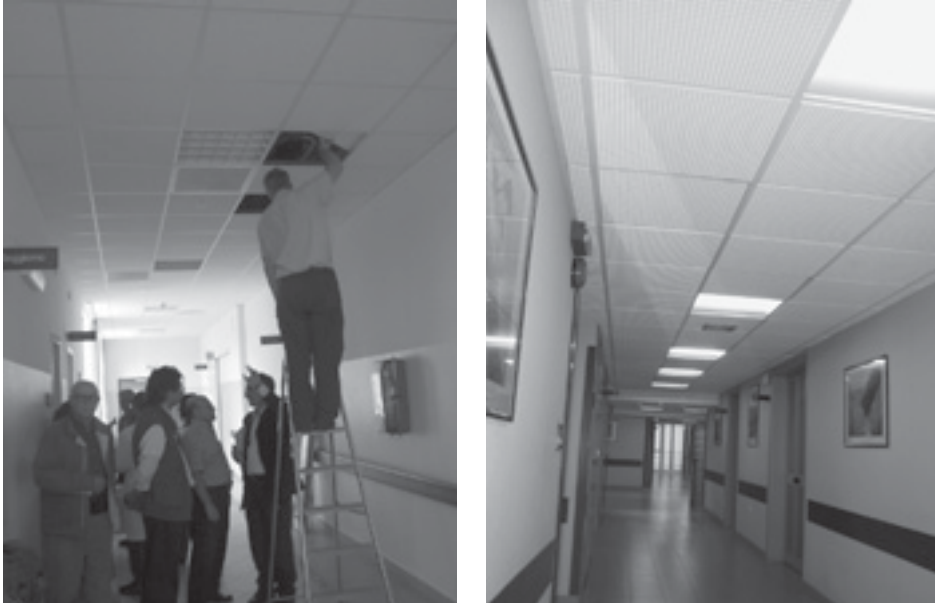
Figure 12.2. Seismic characteristics and recommendations for a suspended grid ceiling in Italian hospitals

Vulnerability. *Medium to High.* Ceiling panels can fall in an earthquake, although they are usually not hazardous. In some cases, panel collapse can cause panic and impair evacuation.

Importance. *Low.* Damage to ceilings typically will not seriously disrupt the hospital's post-earthquake operations.

Specific examples are provided in the ATC-51-2 Report, which indicates when seismic evaluation and anchoring are required, considering both new and existing installations. Twenty-seven example components are presented, and each non-structural component is assessed in terms of its vulnerability, importance, and cost and disruption to retrofit. Based on these attributes, a recommendation indicates in which zones the component should be retrofitted, and in which zones seismic anchoring should be part of new installations. Each example component is summarised using photographs, a summary assessment of the component attributes, and recommendations for evaluation and anchoring (Figure 12.2).

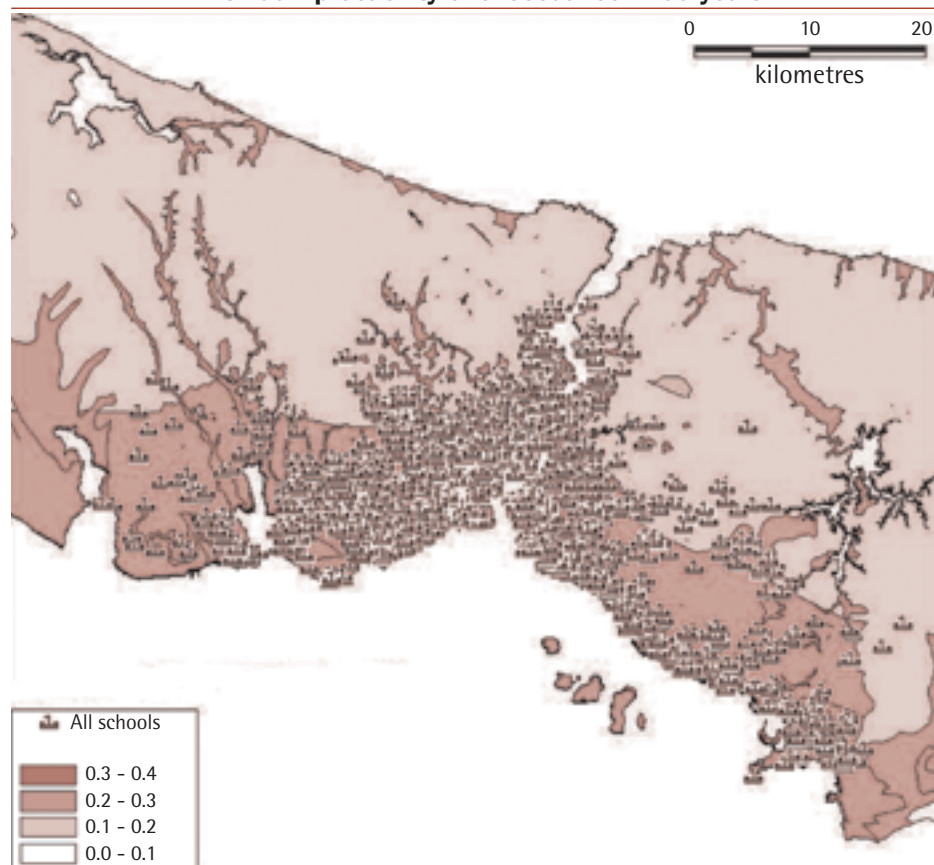
Figure 13.1. School building stock in Istanbul overlain on Code Hazard Map, with 50% probability of exceedance in 50 years

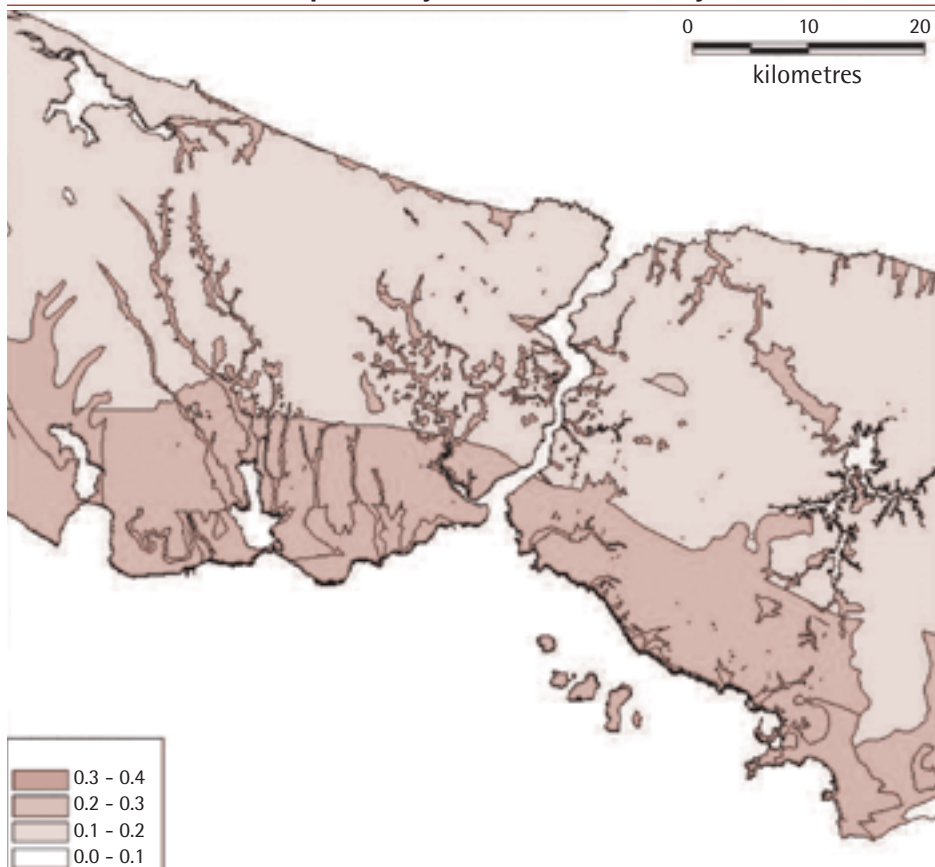
Figure 13.2. Earthquake hazard map for Istanbul, with 50% probability of exceedance in 50 years

50 years). It should be noted that with this earthquake exposure, the school building should perform almost linearly with a Seismic Load Reduction Factor of $R_a(T)$ less than or equal to 1.5. Erdik *et al.* (2004) have prepared an earthquake map for Istanbul that corresponds to 50% probability of occurrence in 50 years (Figure 13.2) using sophisticated state-of-the-art techniques. Hazard information is provided in terms of peak ground accelerations at 0.2 s and 1 s periods. Figure 13.3 presents the seismic hazard zoning map currently used for the retrofit design of school buildings.

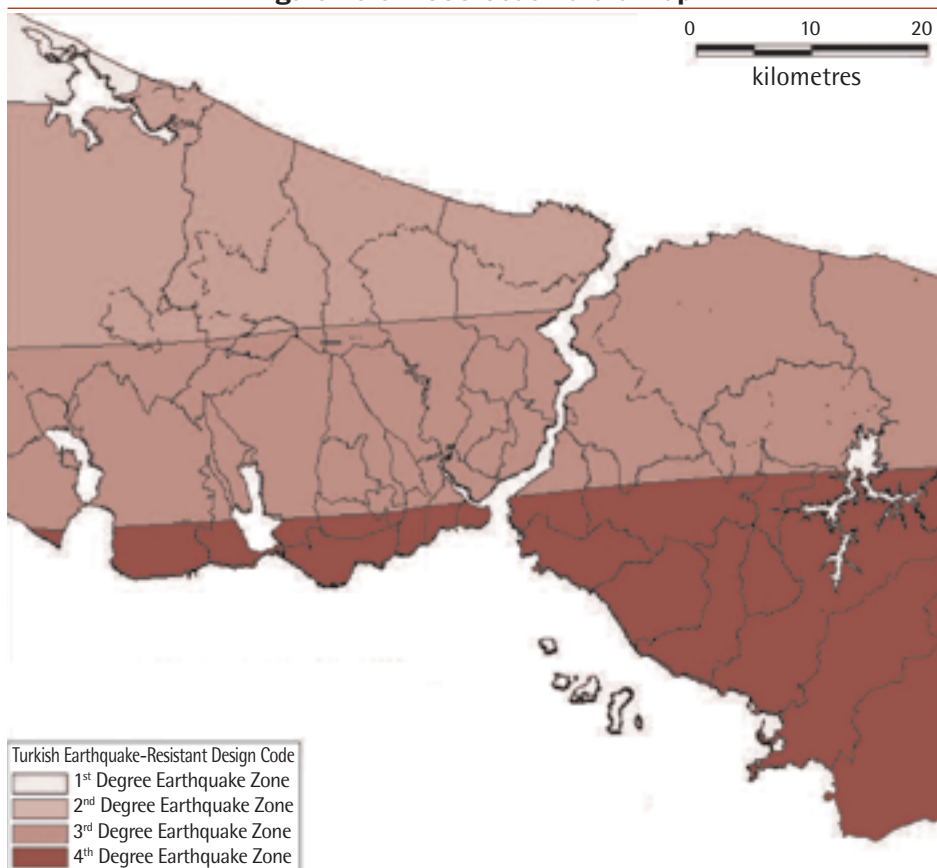
Figure 13.3. 1998 Code Hazard Map

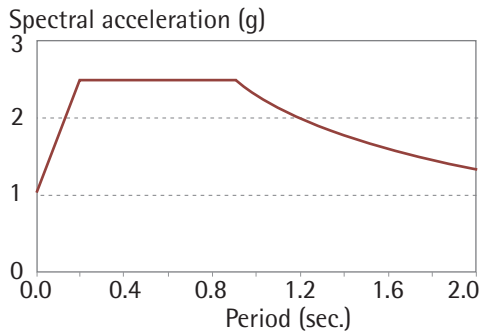
Figure 13.4. Site-specific spectrum for Bakirkoy (1998 Code)

To illustrate the application of the present code using this approach, in Bakırköy, a district in a first-degree earthquake zone with $A_o = 0.4$, the spectrum co-efficient is $S(T) = 2.5$ (Figure 13.4). For a reinforced-concrete frame structure with shear walls, the code allows the use of a seismic load reduction factor $R_a(T) = 7$. The importance factor for schools is specified as $I = 1.4$ in the code. Therefore, the spectral acceleration co-efficient $A(T)$ specified in the code is $A(T) = A_o \cdot I \cdot S(T)$ or $A(T) = (0.4) (1.4) (2.5) = 1.4$, and

the corresponding total equivalent seismic load $V_t = W.A(T)/R_a(T)$ or $V_t = (1.4) / 7 * W$ or $V_t = 0.2 * W$, where W is the total weight of the structure.

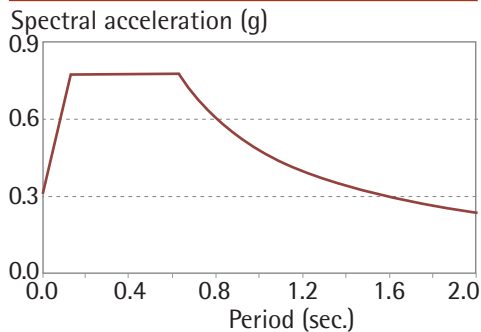
Figure 13.5. Site-specific spectrum for Bakirkoy, with 50% probability of exceedence in 50 years

If a similar computation is carried out, but instead using the spectrum developed for the same district corresponding to an earthquake hazard of 50% probability of occurrence in 50 years, with a spectral acceleration of 0.78 (Figure 13.5): $R_a(T) = 1.5$, the total equivalent seismic load becomes $V_t = (0.78) / 1.5 * W$ or $V_t = 0.52 * W$.

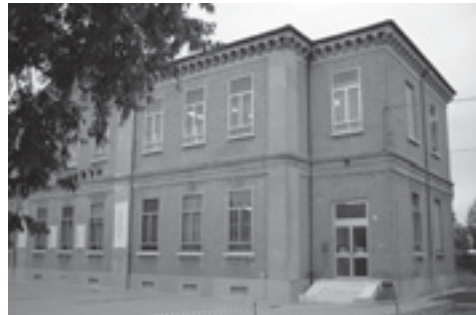
- *Stand-alone masonry buildings* (Figure 14.1) have timber roofs and two to three storeys, with a rectangular plan and regularly spaced windows. Most of these buildings constructed between 1900 and 1940 are primary schools and are owned by the city administration. The rooms are approximately 3.5 m tall, placed along two rows on the facade and connected by a central isle. Foundations are typically made of non-reinforced concrete beams aligned under the main walls. Floors were originally constructed using steel beams and hollow brick units, but due to schools' maintenance or widening, it is possible to find different constructions, often in the same building. The roofs, in general, do not present a rigid diaphragm and are composed of light timber elements. The mechanical properties of materials, though not very good, are usually similar in the different buildings of this category.

Figure 14.1. A stand-alone masonry school building in Ferrara County

- *Stand-alone masonry buildings* are characterised by a very low ductility, tall and large-span rooms that give rise to buckling sensitivity, high shear stress peaks, and flexible floor slabs and roofs. One of the main vulnerability factors is the numerous and wide window openings, which introduces a stress amplification into the reduced width shear-resistant panels. The experimental evidence of damage in recent earthquakes shows that these panels fail in shear with a brittle behaviour (Figure 14.5(a)). Other vulnerability factors are:

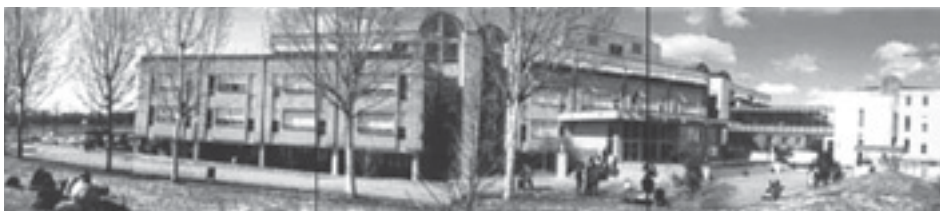
Figure 14.2. A reinforced-concrete framed school building in Bologna

- *Reinforced-concrete framed structures* (Figure 14.2), built after 1950, mainly serve as secondary schools and are owned by the county or regional administrations. They are completed with in-filled masonry walls or prefabricated panels. Following "rational

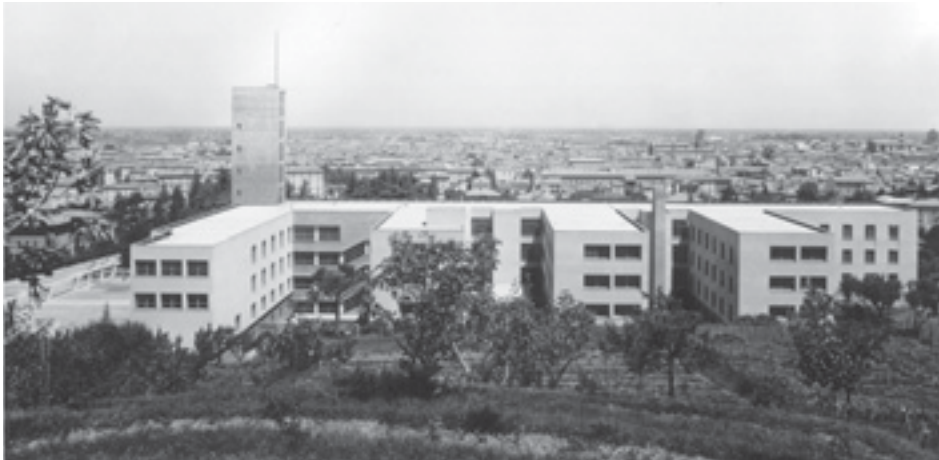
Figure 14.3. The Faculty of Engineering at the University of Bologna

- *University buildings* (Figure 14.3) have been constructed over different time periods and are defined by their complex organisation of space. These structures vary greatly in size and are usually owned by the university administration. These buildings are, in general, stand-alone constructions, although they often comprise several connected blocks.

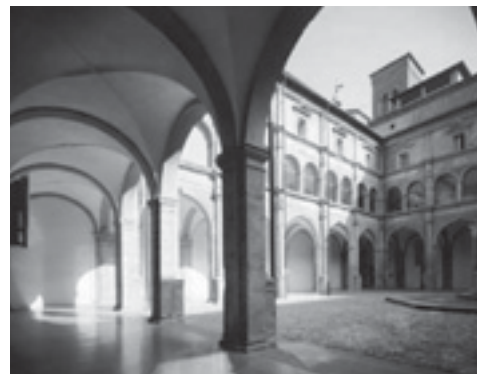
- *Historical or monumental buildings* (Figure 14.4) were built before 1900 and can house a number of educational activities, from elementary school to university, or cultural activities in general. These buildings normally form part of a more complex urban environment and have a strong structural interaction with neighbouring buildings, often allowing for easy escape in case of an earthquake. The structural element typology and material properties range widely as a result of centuries of architectural evolution and recent maintenance. In this sense, the Cultural Heritage Ministry plays an important role in maintaining the original style of the buildings.

Figure 14.4. The interior court of the San Giovanni in Monte building of the University of Bologna

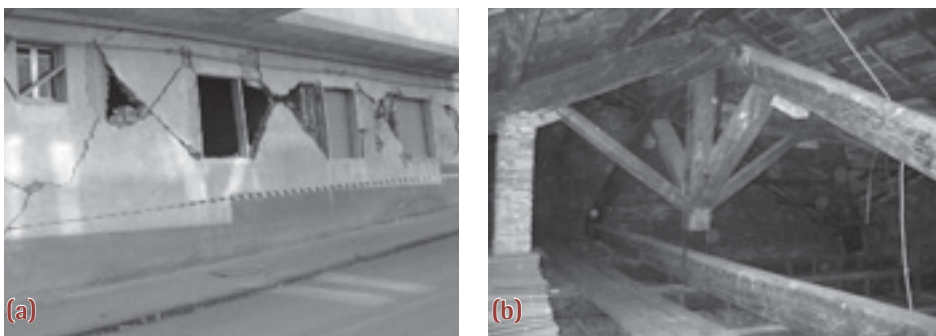
Figure 14.5. (a) Typical seismic damage and vulnerability (absence of a rigid plane at the roof level) of a masonry building, showing the failure of panels in shear with brittle behaviour (b) Perimeter wall failure due to roof element pushing actions

- Out-of-plane instability due to the large-span rooms that have no adequate wall restraint.
 - Perimeter wall failure due to roof element pushing actions (Figure 14.5(b)).

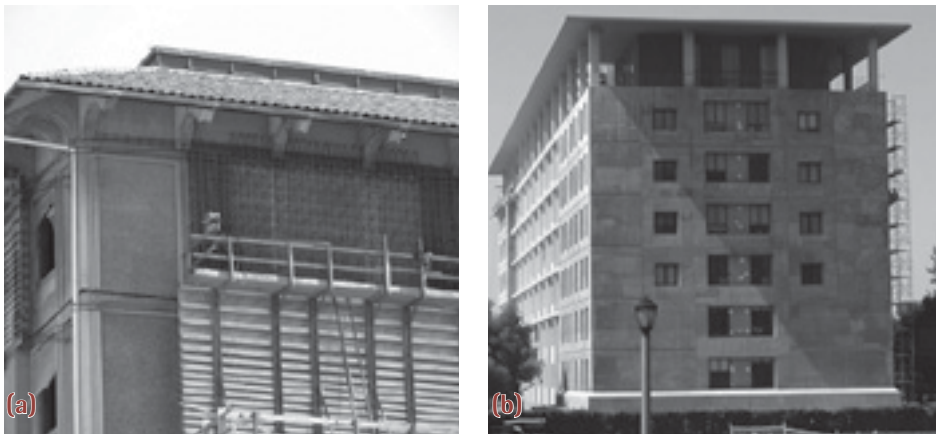
**Figure 14.6. (a) Retrofit work, Berkeley University Campus
(b) Barrows Hall, Berkeley University Campus**

- Figure 14.6(a) shows the construction of new concrete footings and external shear walls, which are attached to existing walls on a new base at Berkeley University Campus.
- Barrows Hall, an eight-storey reinforced-concrete frame and wall building that was rated seismically "poor", was one of the first buildings to be retrofitted in a recent campus-wide initiative (Figure 14.6(b)). The retrofit consisted of new anchored reinforced-concrete walls and foundations, which wrap around each end of the building and are

linked by collector beams extending along the north and south faces of the building on the upper floors. New construction was complicated by requirements to keep the building in full use during work and to preserve window arrangements.

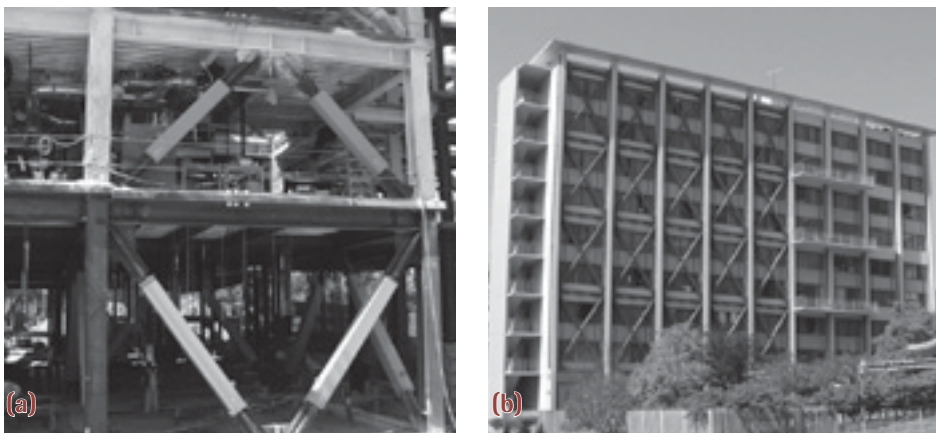
**Figure 14.7. (a) New central dining and office facility on Bowditch Street,
Berkeley University Campus (b) Student residences, Berkeley University Campus**

- Figure 14.7(a) presents a new four-storey central dining and office facility on Bowditch Street. This steel-frame building used unbounded braced or “buckling restrained braced frame” (BRBF).

- The student residences shown in Figure 14.7(b) comprise an externally retrofitted, concentrically braced steel frame and shear wall. The older reinforced-concrete framed building is now rated seismically “good”.

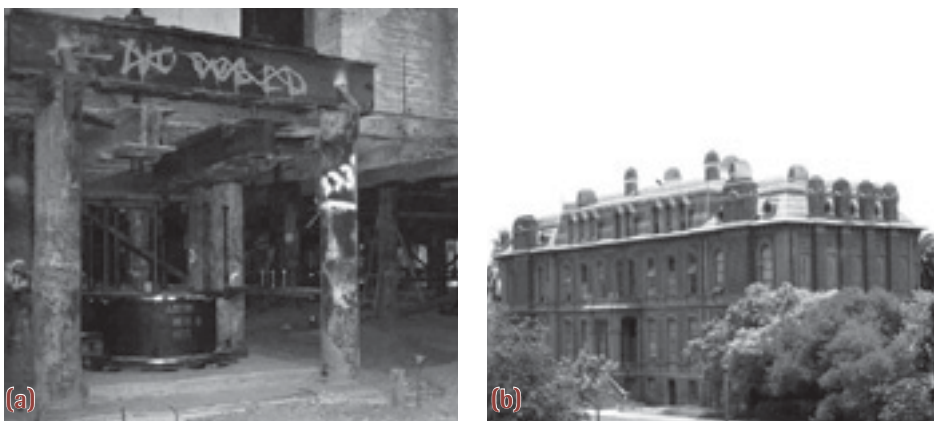
- The building shown in Figure 14.8(a) is located close to surface tracings of the Hayward Fault. It was rated seismically “very poor” before the retrofit. The reconstruction used high-damping rubber base isolation bearings and preserved most of the building’s original details.

- South Hall (Figure 14.8(b)), designed by David Farquharson, is a fine example of late Victorian architecture. South Hall was constructed between 1870 and 1873 using fired brick made of local Bay clay. The original design incorporated a bond-iron framework on granite foundations and some diagonal bracings for earthquake resistance. Interior walls comprise unreinforced masonry. In the 1980s, the building was declared hazardous and a “centre coring” reconstruction scheme was developed to preserve historic wall surfaces and ceilings.

Figure 14.8. (a) Exterior view of excavation, showing temporary supports and scale of the project, Berkeley University Campus (b) Oldest building still standing on the campus, South Hall, Berkeley University Campus

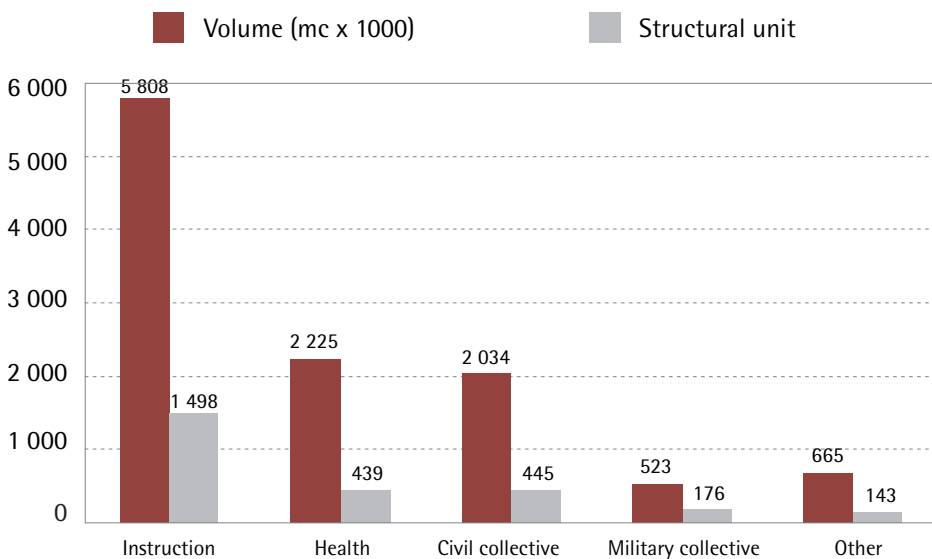
Figure 14.9. Vulnerability analysis from 1989 to 1990

The experience of the Emilia-Romagna Regional Administration (see www.regione.emilia-romagna.it/geologia/Sismic.htm) began in 1986 in 12 municipalities located in Emilia Appennino. It continued between 1989 and 1990 with the completion of a vulnerability investigation of about 2 700 strategic buildings – hospitals, schools and town halls – in 76 municipalities that were classified as seismically prone in 1983 (Figure 14.9). Currently, the regional administration is preparing to update and extend this analysis. A substantial agreement between all Italian regional administrations was reached recently concerning the necessity of having a common simplified but validated method to select buildings and create a priority list for seismic retrofit.

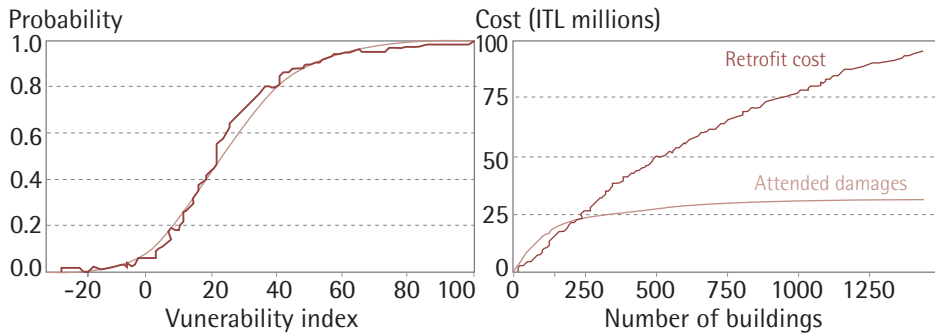
Figure 14.10. (a) Distribution of the buildings' vulnerability index
(b) Cumulative curves of attended damages and preventive seismic retrofit costs

In the course of these investigations, vulnerability was estimated by means of fragility curves, which relate the damage index $d(y,V)$, expressed as a percentage of the building value, to the vulnerability index V and the peak ground acceleration y . y_i and y_c are the first damage and the collapse accelerations, respectively. Details on the procedure and the parameters used in the numerical models can be found at www.gndt.ingv.it → *Strumenti* → *Schede di Rilevamento*. The user manuals can be downloaded at www.regione.marche.it/terremoto/VulnEntry.htm.

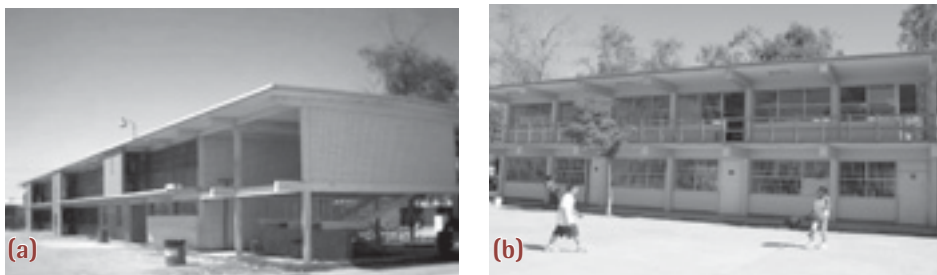
A prototype school model was developed based on rough descriptions, photographs and other qualitative information (Figure 17.1).

Figure 17.1. Typical school structures in Mexico

(a) School in Guerrero (b) School in Mexicali
(Photos courtesy of Brian Tucker, GeoHazards International)

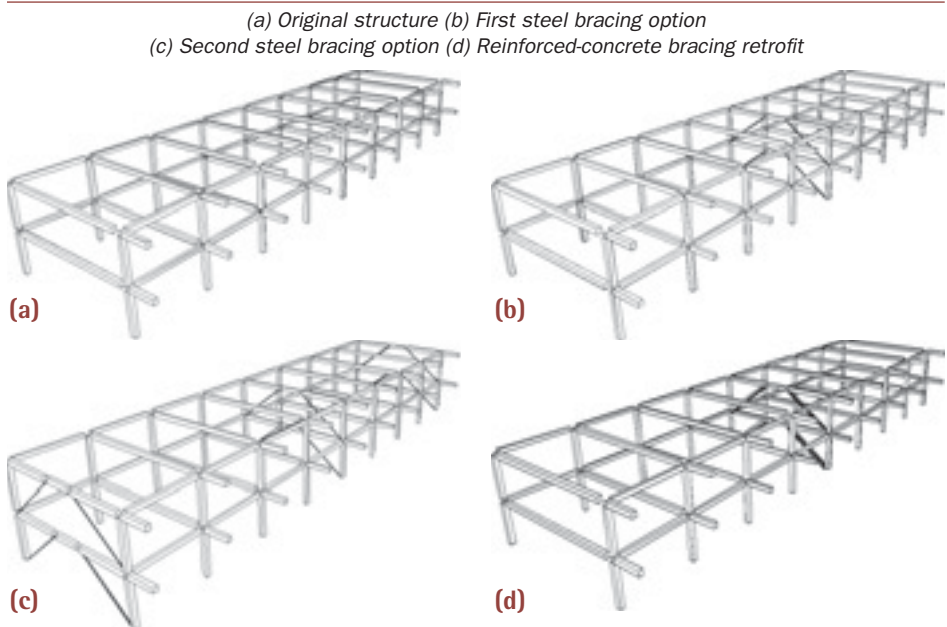
This structural model consists of a two-storey building with a footprint of 10 m × 40 m and a storey height of 3 m. The structure, the frame of which is shown in Figure 17.2(a), is divided into eight bays with a width of 5 m in the long direction and one bay with a width of 10 m in the short direction. A 2 m cantilevered slab on each floor acts as an access corridor for the different classrooms.

To mimic possible poor design practice in developing countries, no lateral loads such as seismic loading were considered in the design. The structure was designed for gravity loads, which include the weight of the structural elements (beams and columns), the weight of the slab, and permanent elements estimated at about 2.50 kN/m². A live load of about 1.91 kN/m² was also considered. These loads are applied on both storeys to allow for the typical practice of constructing additional floors. The material is assumed to be reinforced concrete of average quality with a concrete compressive strength of 20 684 kN/m² and a yield strength of 413 686 kN/m² for the steel. The mass of each of the elements is considered, and additional masses are added on each floor to simulate the slabs. The Eurocode 1999 is used for dimensioning the steel reinforcement with the appropriate safety factors for loads and materials. As designed, the structure is vulnerable; it is capable of appropriate standard service loads but unfit to sustain any strong loads other than gravity.

Figure 17.2. Model of the structural frame for the original and retrofitted structures

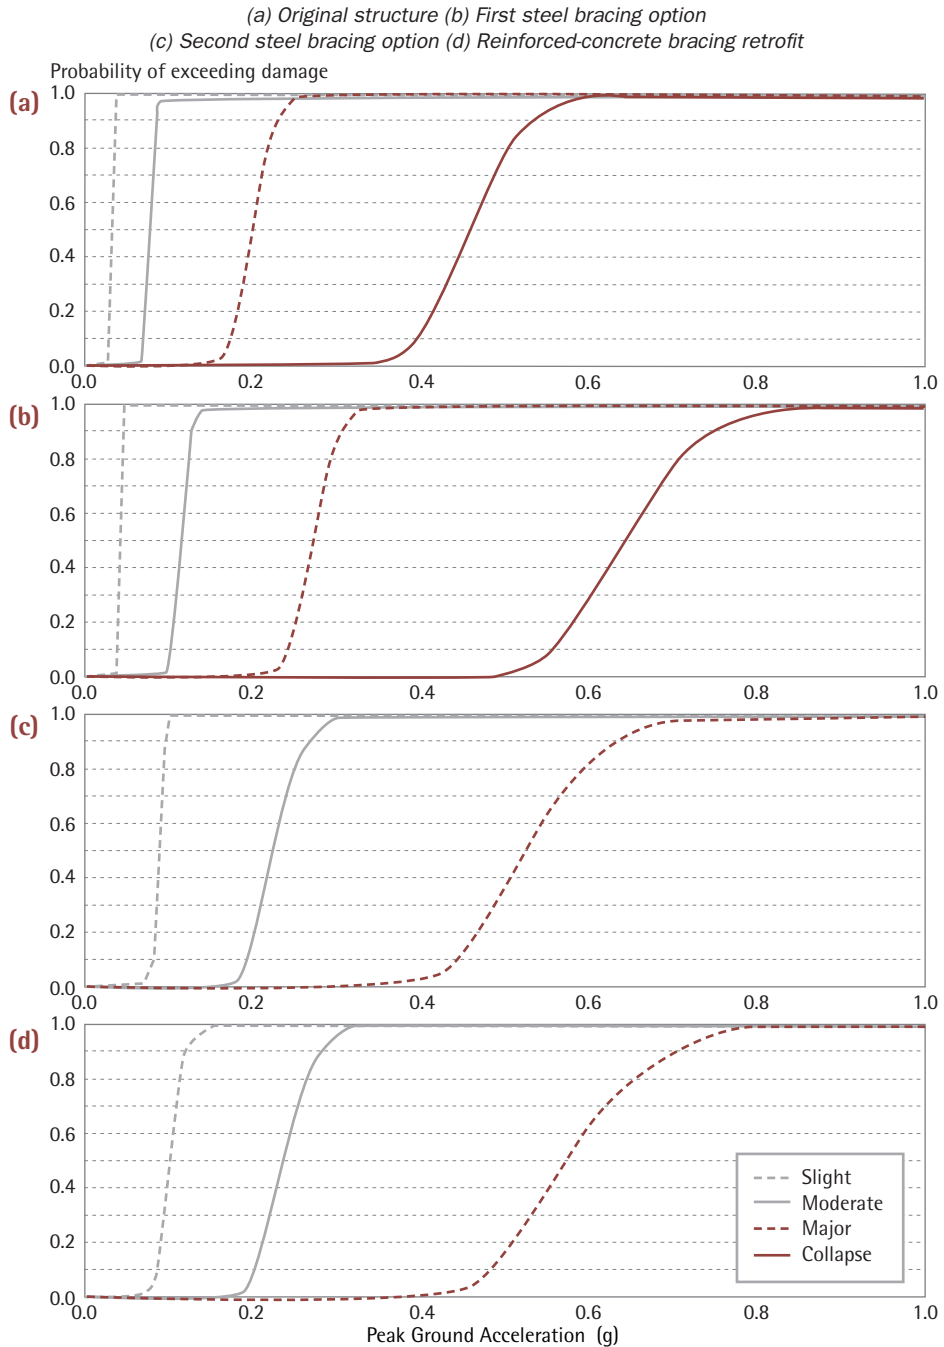
The fragility of a given structure is defined as the probability that for a given ground motion shaking level (peak ground acceleration), the structural response will exceed a given threshold level corresponding to a particular damage level. The structural response is probabilistic in terms of peak ground acceleration (PGA) because the structural response deformations will, in general, be different for different ground motion time histories with the same PGA. For each of the structural configurations, the fragility curves are shown in Figure 17.3. Four damage levels E_i are considered: slight, moderate, major and total collapse. These damage levels are defined by inter-storey drift ratios in accordance with the HAZUS99-SR2 Technical Manual. Note that retrofit strengthening has the effect of pushing the fragility curves to the right, *i.e.* for the same PGA value, the probability of exceeding a given damage state is lower.

Figure 17.3. Derived fragility curves for the four structural configurations

$P(E_i \text{ only} | a)$ = the probability of only event E_i occurring for a given PGA value a . This probability is needed so that damage levels which are lower than (or fall within the set of) more severe damage levels will not be counted twice. This expression is easily related to fragility curves.
