# Seismic Retrofitting Quick Reference

## School Facilities that Withstand Earthquakes

# Introduction

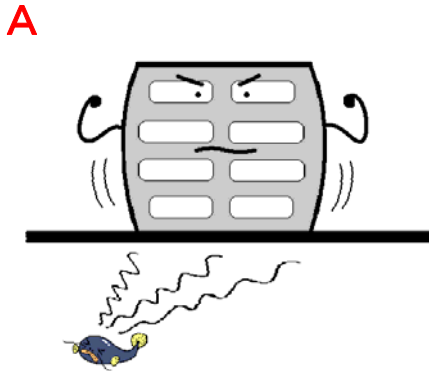
Structure with high strength, low ductility.

**C high**

**F low**

A structure with high strength A may appear to be more resistant to earthquakes. However, Structure A lacks ductility, and when the acting force exceeds the limit, the structure would suddenly collapse. On the other hand, the strength of Structure B is low, but the structure shows tenacious resistance before collapsing. Therefore, increasing the seismic performance of structures is possible by increasing the strength, such as in Building A, or increasing the ductility of the structure, such as in Building B. It is not always the case that a structure with higher strength is more resistant to earthquakes. It is important to consider the resistance against earthquakes from two indices; strength and ductility.

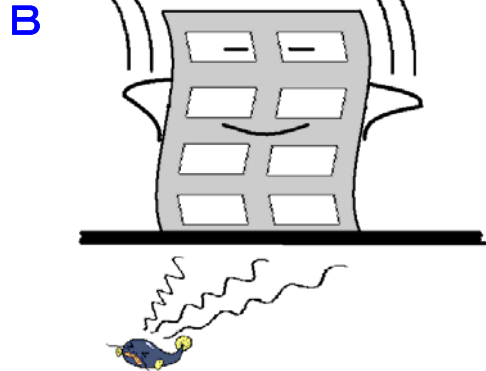
Structure with low strength, high ductility.

**C low**

**F high**

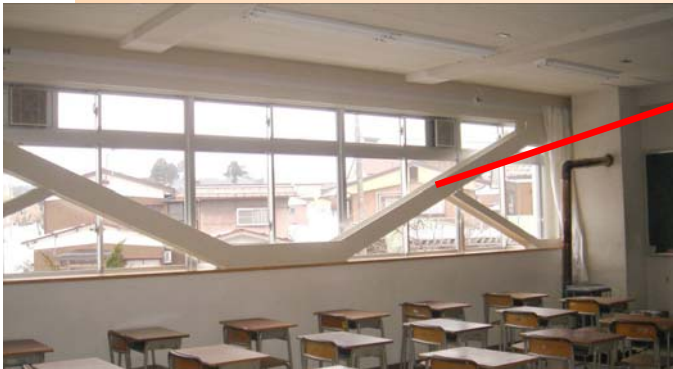
Steel bracings (diagonal)

After retrofit (Inside view)

Wall girder

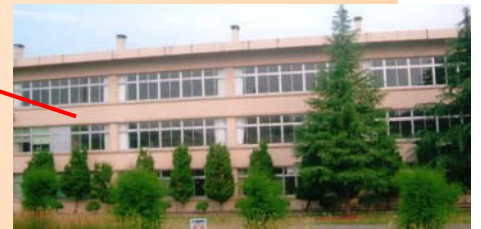
Before retrofit (outside view)

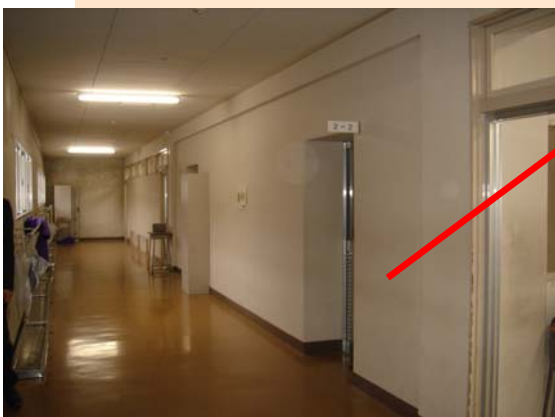
installed shear wall

After retrofit

The building has two staircases at the west side of the structure. Although shear walls are installed in the ridge direction of the structure, there are wide openings and other multiple openings, and it is assumed that the shear walls are not very effective. The external frame of the structure at both grid lines A and C are wall girders, and the columns along grid line C were extreme short columns<sup>1)</sup>. From seismic evaluation results, the first and second floors showed *I<sub>s</sub>* values of 0.30 in the ridge direction and the first floor showed *I<sub>s</sub>* values of 0.69 in the span beam direction. Therefore, the planned retrofitting method was to resolve the extreme brittle columns<sup>2)</sup> by installing wing walls, sealing openings, and to improve the structure that lacks strength by installing steel bracings at openings and shear walls.

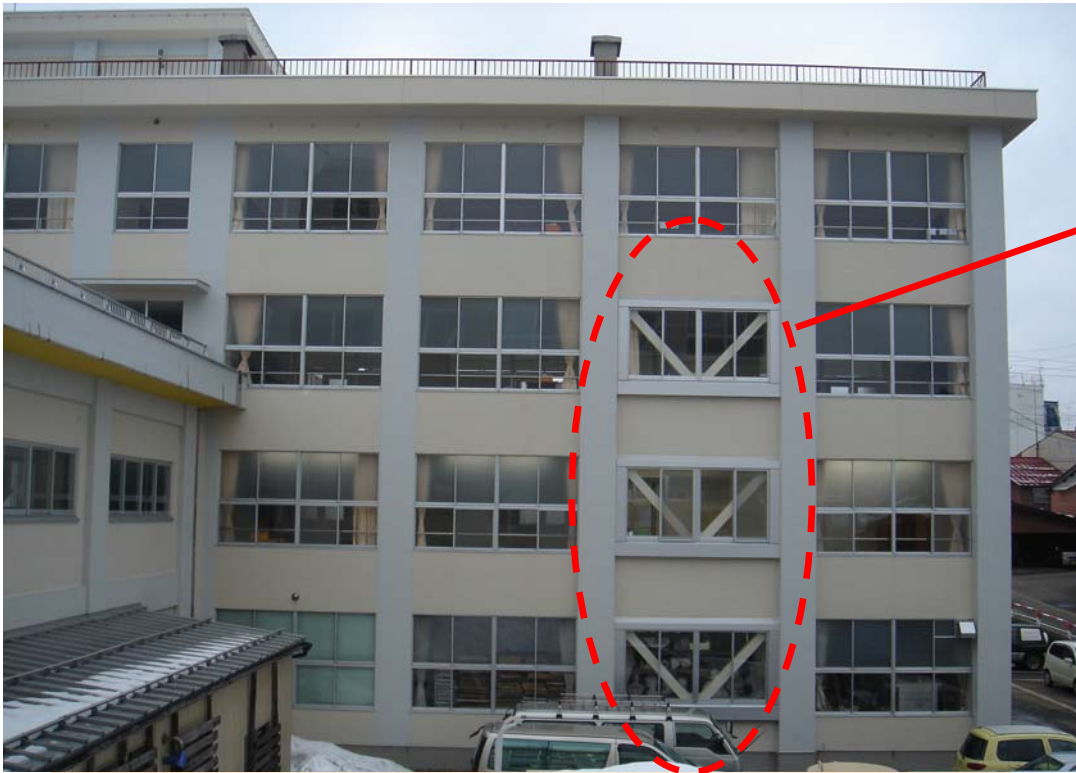
After retrofit (outside view)

steel brace

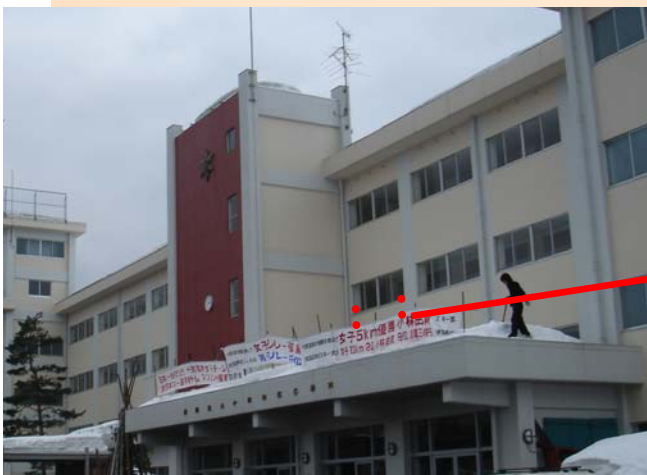
Before retrofit (outside view)

Structural slits<sup>1)</sup>

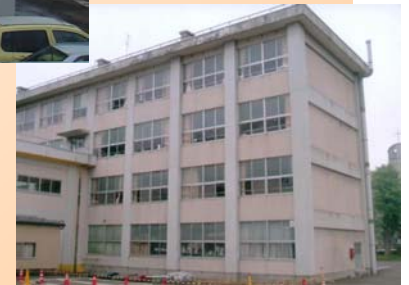
After retrofit (outside view)

Slits are gaps that are placed between the spandrel walls and column to prevent failures caused by concentration of strength at the columns during earthquakes.

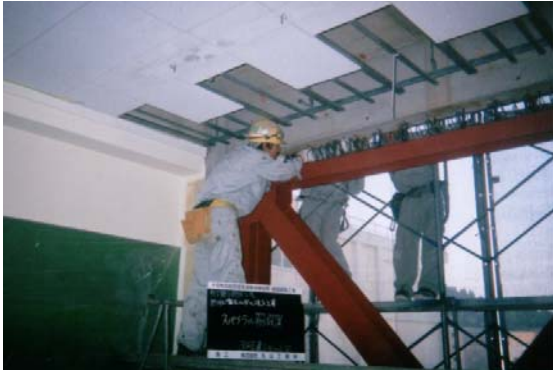
Installing a steel bracing

The retrofitting methods were as follows: new installation of steel bracings; installation of 'structural slits' by placing vertical slits adjacent to columns in standing and hanging walls in each floor; for columns that are structurally important, jacketing columns with carbon fiber; or for soft story columns, wrap with steel plates to reinforce the columns; as well as, installation of additional shear walls with openings to columns (only on the first floor). The new steel bracings are K-shaped and W-shaped bracings. Along grid line A, facing the special classroom building and where it is possible to close all except the doorway, W-shaped steel bracings are installed. At other openings that are outward facing and in the ridge direction, the distinctive K-shaped bracings that are angled at almost 45 degrees were installed.

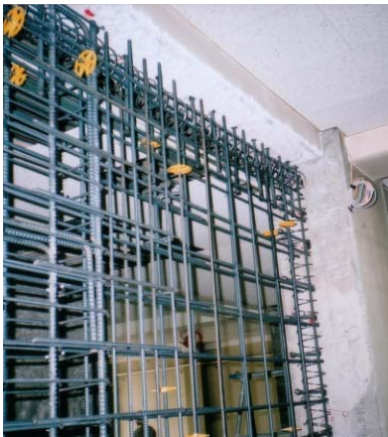
Adding the seismic shear wall

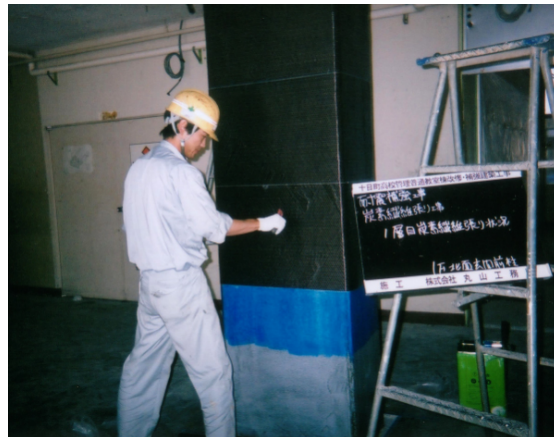
Carbon fiber jacket column reinforcement

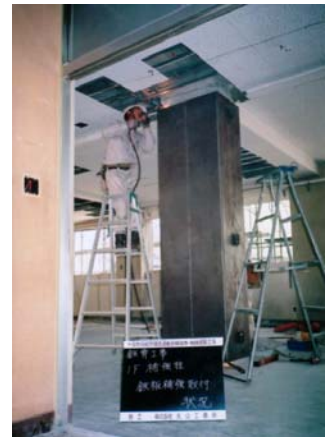
Steel jacket column reinforcement

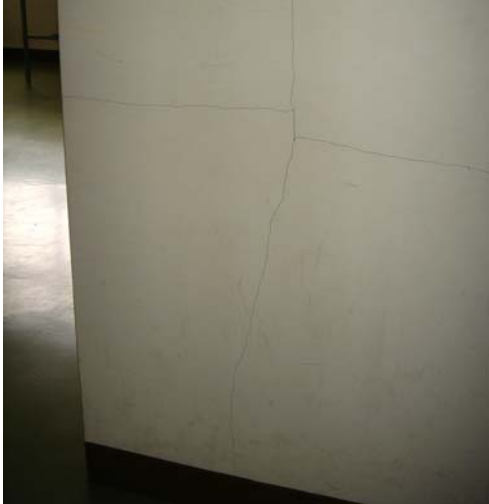
Surface cracks after the earthquake

It is assumed that the structure sustained a significantly high maximum acceleration from the earthquake that was equivalent to seismic intensity 6 lower. However, the damage level was minor even when some parts of the retrofit work were not completed. In the building, there were overturned furniture, broken expansion joints<sup>2)</sup>, and shattered glass. However, in the ridge direction of the structure, damages were minor and only microcracks were observed, apart from the standing wall. Columns along grid line G, where vertical slits were placed at spandrel walls, showed flexural cracks<sup>3)</sup> and verified the effectiveness of the slits. Columns that were reinforced by carbon fiber jackets showed significant cracking of the surface finish. Technically, it is assumed that the column had effectively resisted the seismic forces. However, it was difficult for the users to distinguish these cracks from structural cracks and made them feel rather insecure. In the beam span direction, shear cracks<sup>3)</sup> were rather significant at the shear walls and corners of openings. Therefore, damages were rather more significant in the beam span direction. This seems to be related to the directionality of the earthquake, which was strong in the north-south direction.

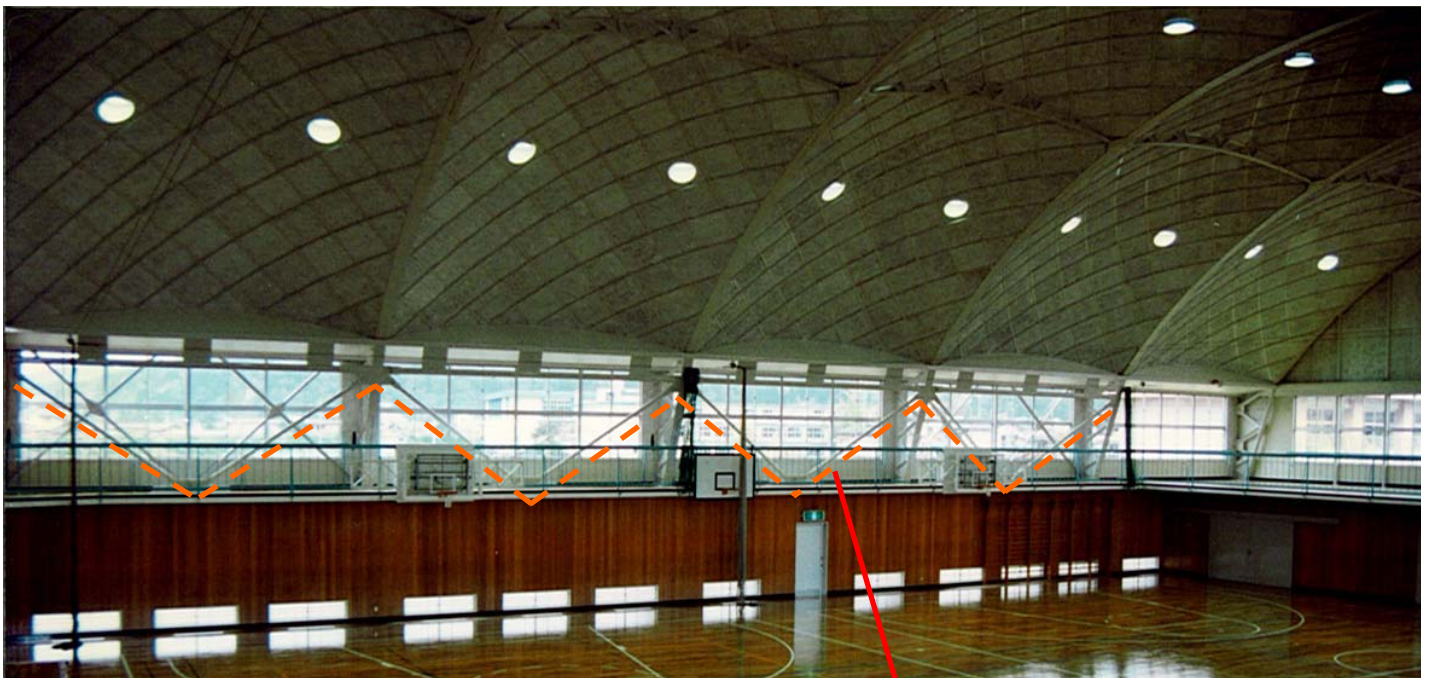
After retrofit (inside view)

Steel Tube Bracings

From the seismic evaluation, in the ridge direction, the *I<sub>S</sub>* value was 0.77 at the first floor and 0.08 at the second floor. Therefore, by adding steel bracings at eight positions in the ridge direction at the second floor, the *I<sub>S</sub>* value after retrofitting was 0.73. This type of roof allows load transfer. Since the column-beam joint in the beam span direction is not a welded joint and the column base did not have a problem, the *I<sub>S</sub>* > 0.7 was secured. The lack of load bearing capacity in the ridge direction was reinforced by adding K-shaped steel tube bracings. Since the column is a latticed member, and could not bear the installation of bracings, this was reinforced by installing an upper chord member with the bracings in an inverted triangular formation.

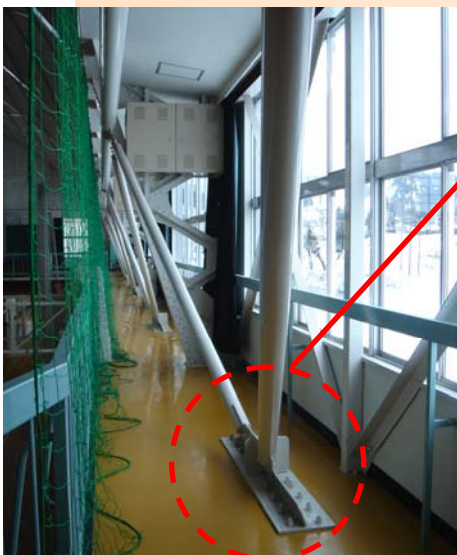
Anchor section of steel tube bracings

## Anchors

Anchors to fix bracings. In this case, the steel tube bracings were anchored to the floor at the second floor instead of the lower base of the column to avoid stress acting on columns.

At the lower intersection of the inverted triangle, the bracings are anchored to the gallery floor to avoid imposing loads onto the existing column base.

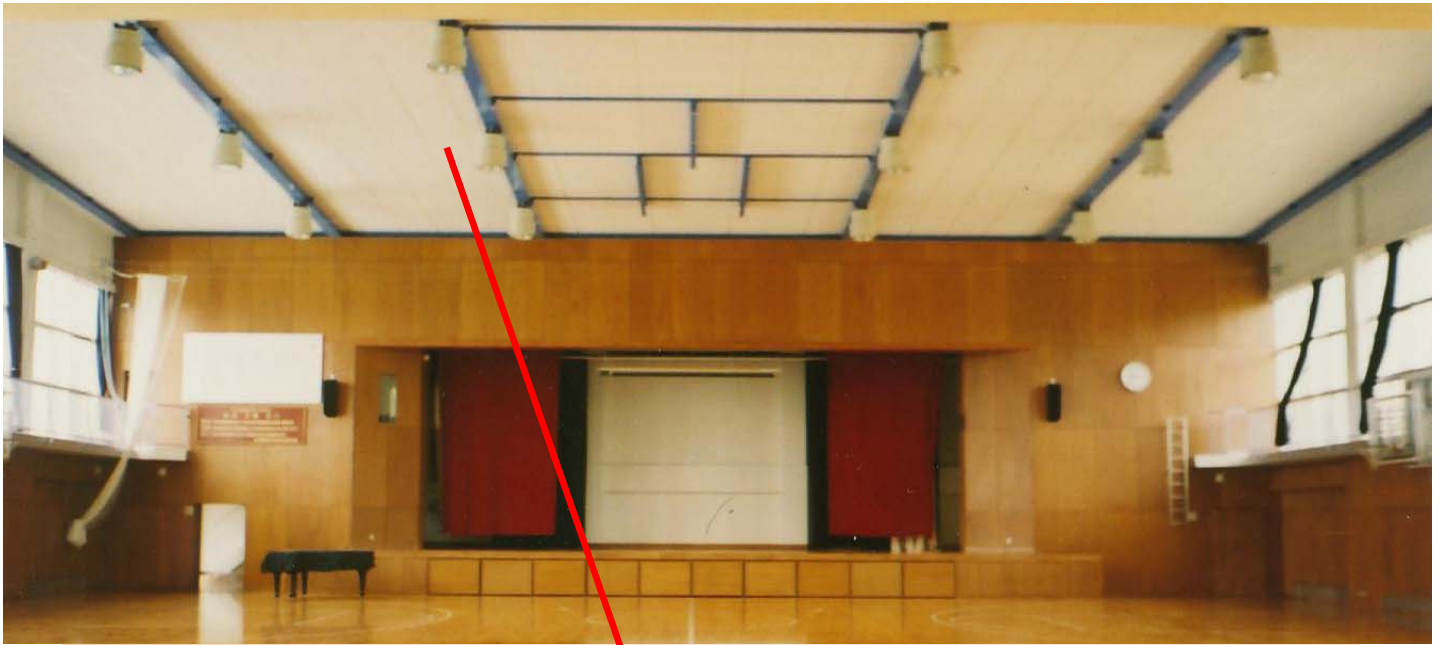
Steel structured roof

After retrofit (outside view)

The in-plane seismic performance of the frame along the periphery was secured, but the precast concrete slab roof lacked in-plane rigidity and strength. Due to concerns that the precast concrete slab could fall, the roof was replaced with a steel framed roof to improve seismic resistance by reducing the dead load and increasing in-plane rigidity and strength.

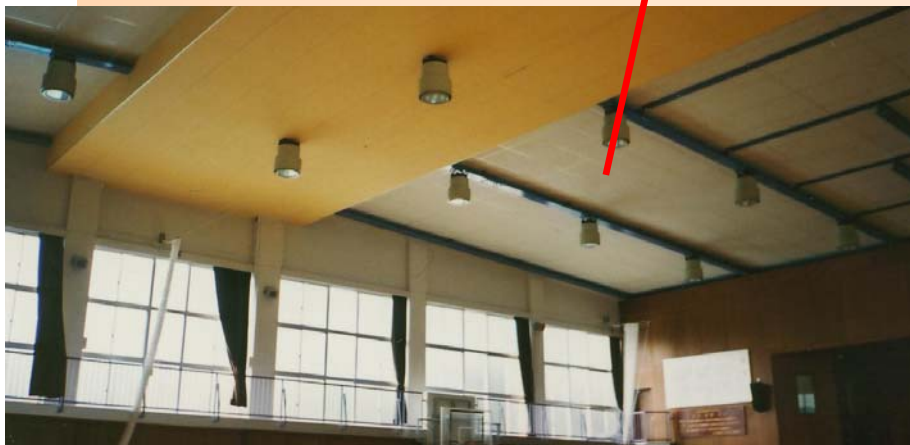
After retrofit (inside view)

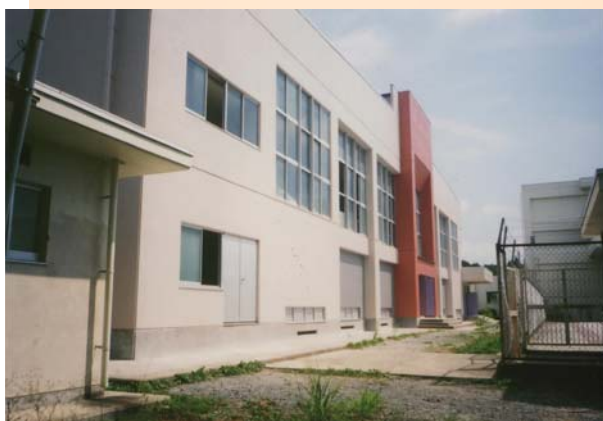
After retrofit (outside view)

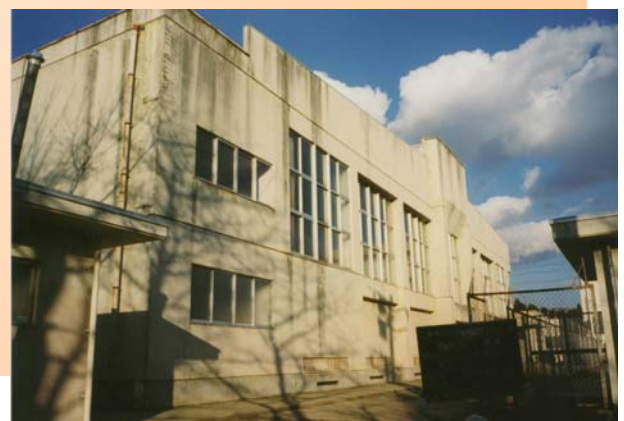
Before retrofit (outside view)

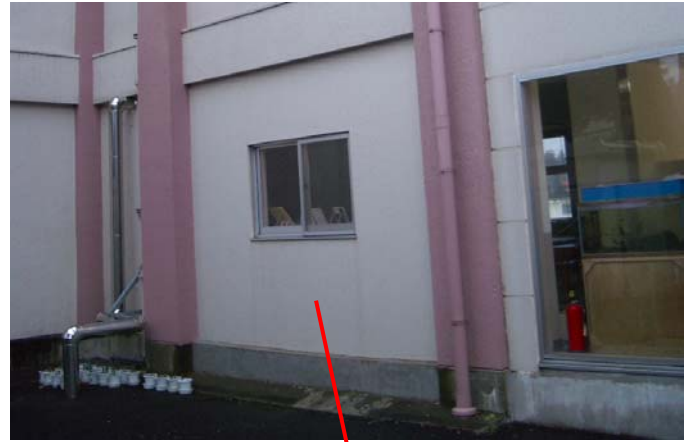
Installed shear wall

In the beam span direction, shear walls along partition walls that separate classrooms secure the necessary seismic resistance in all floors. However, there were not enough shear walls in the ridge direction, and many columns were prone to shear failure. Therefore, it was judged that the structure does not have the necessary seismic resistance at the first and second floors. The  $I_s$  values in the ridge direction for the first and second floors were evaluated as 0.52 and 0.48.

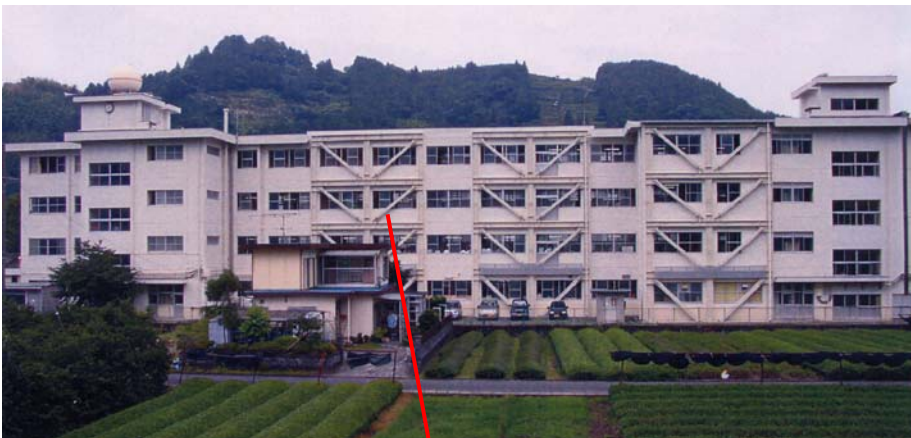
After retrofitting (exterior)

External steel bracings

Retrofitting the school building was performed by installing external steel bracings and reinforced concrete shear walls, and by making the roof lighter to reduce the weight of the structure. 32 sets of external steel bracings and 2 sets of reinforced concrete shear walls were installed.

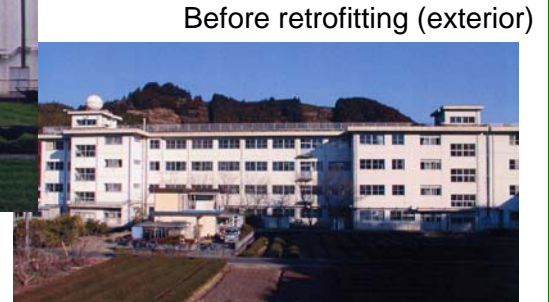
Before retrofitting (exterior)

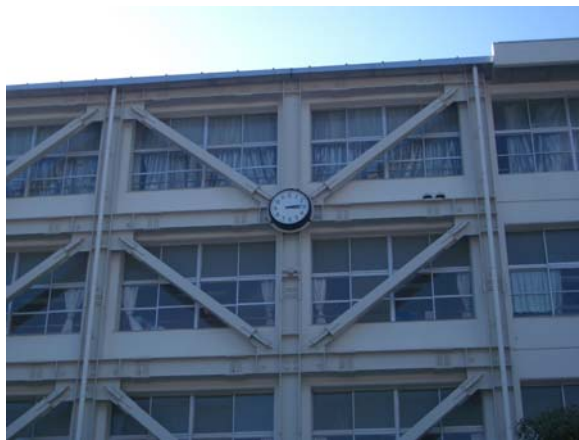
After retrofitting (exterior)

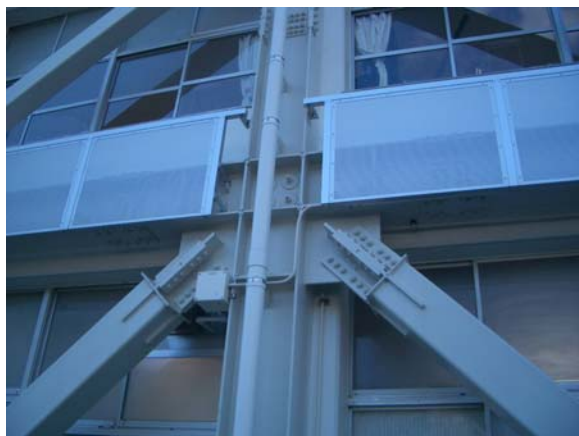
After retrofitting (details)

Silicon resin coatings were applied over the anticorrosive coat on steel members, such as bracings. Since it is just two years after completion of work, there is no problem, but it is preferable to establish a maintenance plan, such as against corrosion in the future.

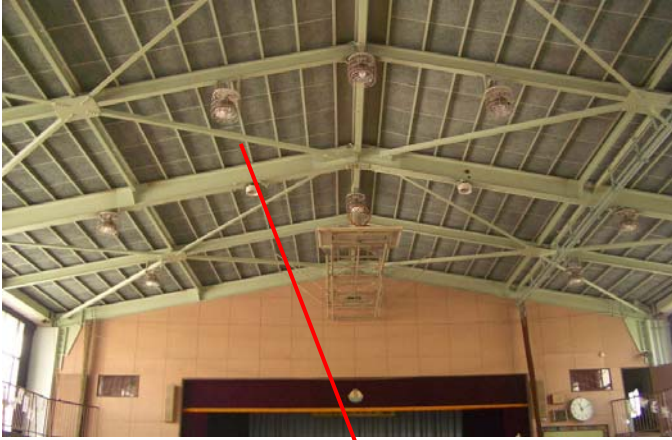
Bracings along the roof

Retrofitting method for the gymnasium at Shinjuku Elementary School is as follows: Install bracings along the entire ceiling to increase rigidity of the roof. Install K-shaped steel framed bracings at two positions to increase seismic resistance in the ridge direction. Install rib-plates to reinforce the column-girder joint.

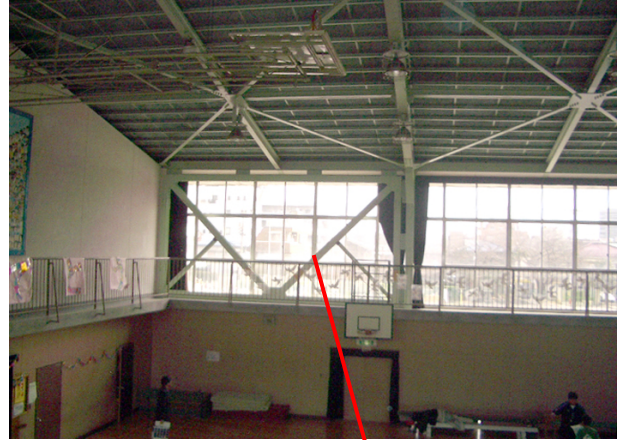
Steel bracings

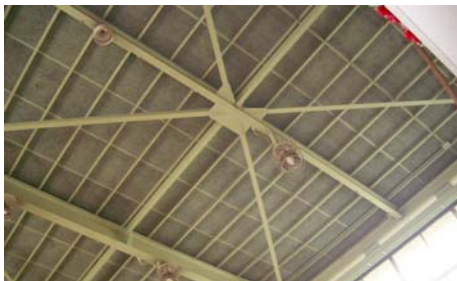
Bracings along the roof Detail

The retrofitting was as follows: Install horizontal bracings along the entire ceiling to improve load transfer along the roof. Install K-shaped bracings (with upper and lower frame members), made of wide-flange structural steel, in the ridge direction to improve the lack of seismic resistance at the second floor. This is a common retrofitting method.

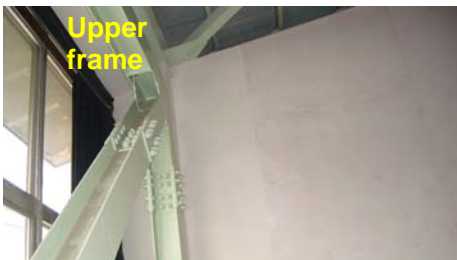
Steel bracings Detail-1

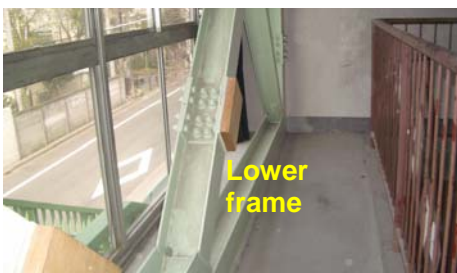
Steel bracings Detail-2

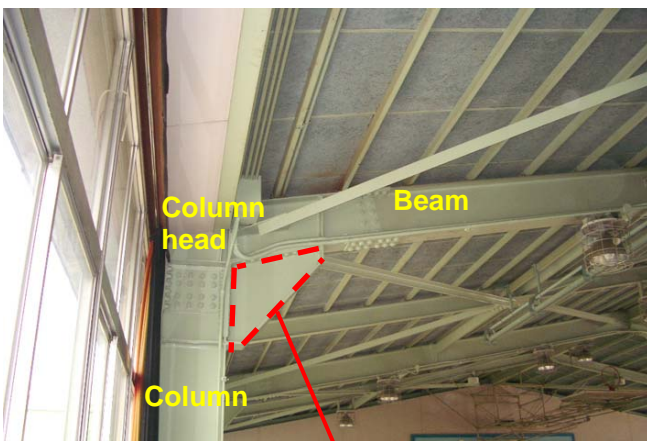
Reinforce column-beam joint by installing rib-plates

For the beam span direction, it was judged that the weld strength of the welded column-beam joint at the column head was insufficient. Therefore, rib-plates were installed at the corner of the column-beam joint to reinforce the joints. The reinforcement with rib-plates simultaneously supplements the two weaknesses; the column-beam joint and the welded column joint. By fastening the rib-plate to the lower flange of the beam and to the column with high-strength friction grip bolts, it straddles the welded column joint to connect the beam and column.

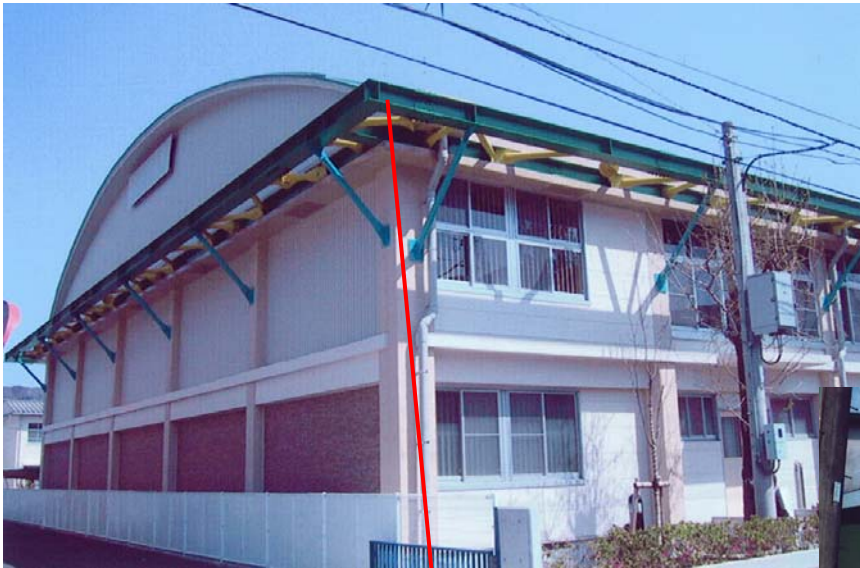
After retrofitting (exterior)

External horizontal truss

This retrofitting method applies reinforcement to the exterior of the structure. The existing columns and beams are to be left untouched, and a horizontal structure is installed around the height of the eaves to make this peripheral structure resist out-of-plane forces acting on the structure. The horizontal structure is a truss that consists of chord members made of wide-flange structural steel and steel tubing diagonal members. To connect the truss to the existing structure, post installed anchors were used. Then, non-shrinkage mortar was injected into the space between the existing concrete structure and new steel members.

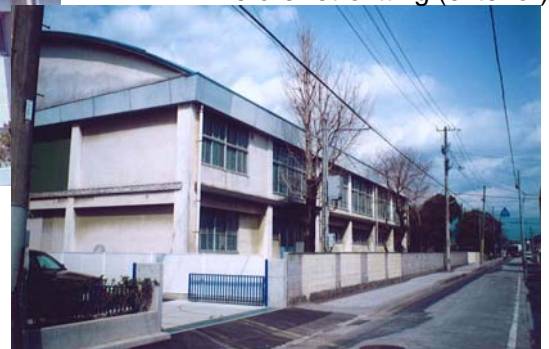
Before retrofitting (exterior)

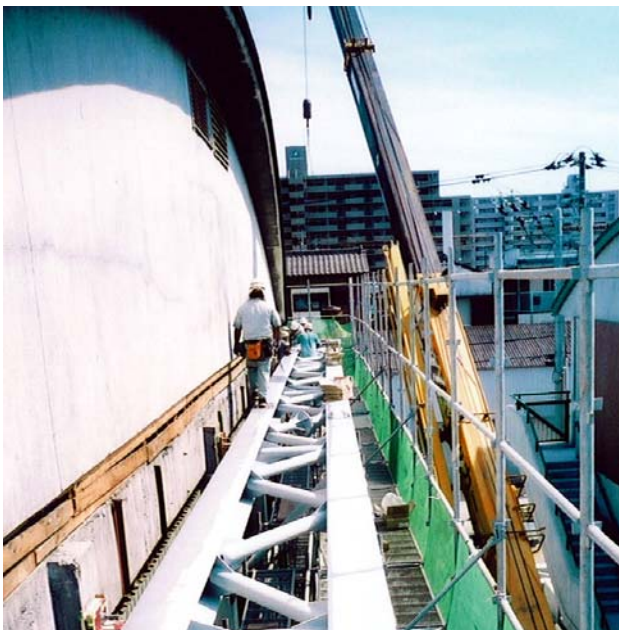
Erection of steel frame

The retrofitting is mainly applied to the exterior of the structure. Therefore, sufficient care is necessary for liftingwork and anticorrosive measures of the steel frame.

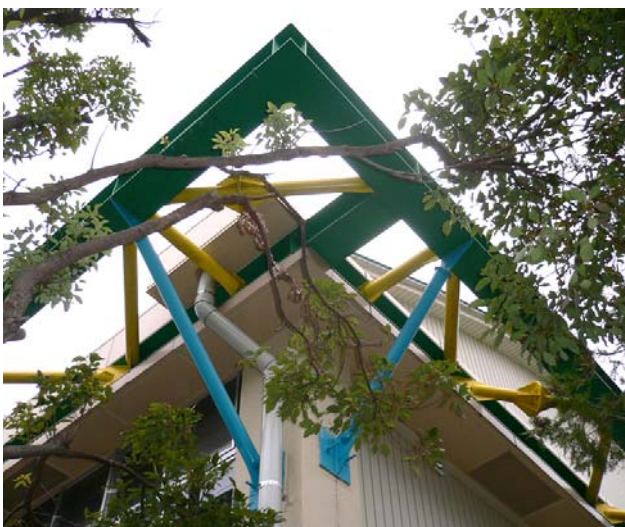
After retrofitting (details)

The roof, which may seem uncommon in elementary and junior high school gymnasiums, is made of steel tubings that compose a single layer lattice shell. This structure is heavy for a gymnasium, because of the reinforced concrete framework. Frequent issues in this type of structure are the out-of-plane vibration of the structure, and the connection between the steel frame and the reinforced concrete portion. In this example, the reinforced concrete framework was reinforced to resist out-of-plane forces by installing a horizontal steel structure (like placing a hoop) around the structure at the position of the eaves.

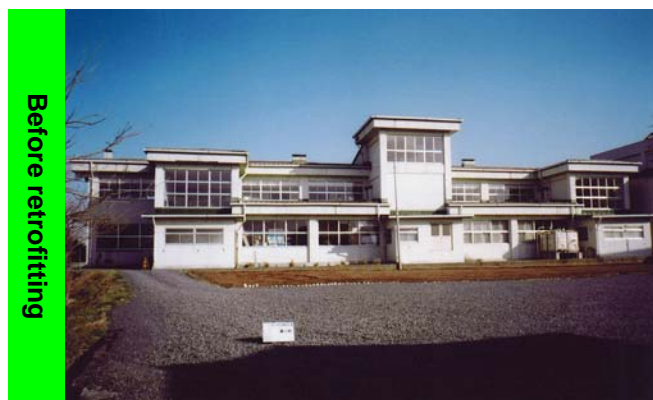
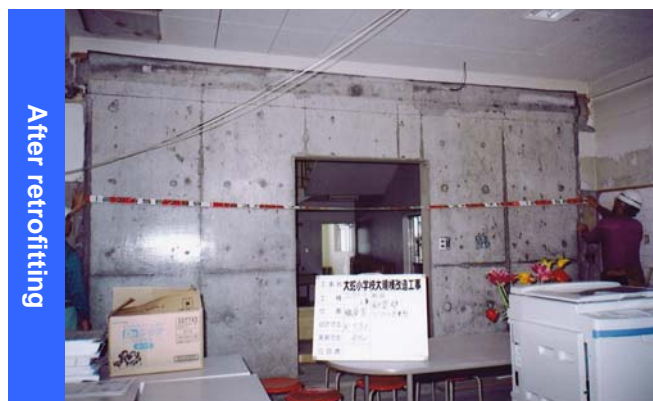
Aomori Pref	Kaijo Town, Ohja Elementary School
Outline of the facility	Structure, Story, Floor area	RC structure, 2 stories Total floor area: 1,326 m <sup>2</sup>
	Work Duration	March to May 2005 (approx. 2 months)
	Total project cost	81.340 million yen
	Approx. cost of retrofitting	Carbon fiber jacket column reinforcement 187,200 yen/m <sup>2</sup> Install RC wall 85,600 yen/m <sup>2</sup>
	<i>I<sub>S</sub></i> Value Before → After	$I_{sx}=0.49 \rightarrow I_{sx}=0.82$ $I_{sy}=1.40 \rightarrow I_{sy}=1.40$

<b>Outline of Seismic Retrofitting Method</b>	
Wrap carbon fiber sheet around column along the corridor, and install RC shear wall adjacent to the corridor.

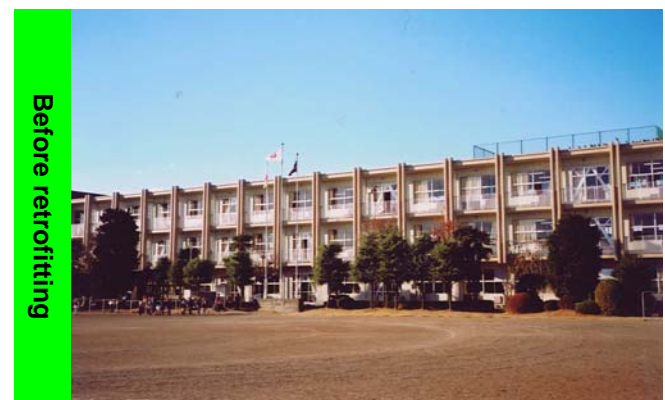
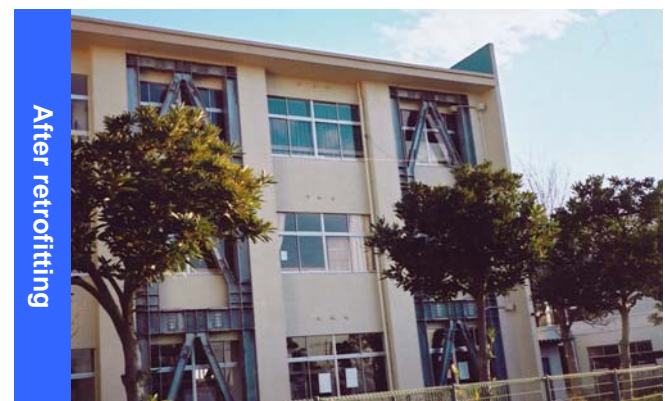
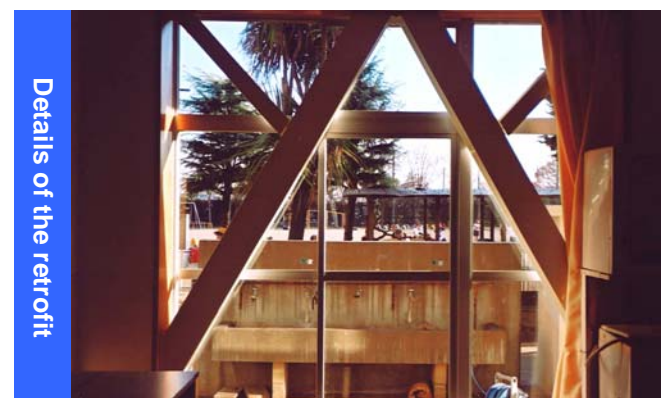
Saitama Pref	Gyoda City, Saitama Elementary School
Outline of the facility	Structure, Story, Floor area	RC structure, 3 stories Total floor area: 3,074 m <sup>2</sup>
	Work Duration	June to September 2004 (approx. 3 months)
	Total project cost	92.4 million yen
	Approx. cost of retrofitting	Steel bracing 1.78 million yen/each External steel bracing (3 levels) 14.45 million yen/each
	<i>I<sub>S</sub></i> Value Before → After	$I_{sx}=0.31 \rightarrow I_{sx}=0.76$ $I_{sy}=0.78 \rightarrow I_{sy}=0.78$

<b>Outline of Seismic Retrofitting Method</b>	
Retrofitting is applied only in the ridge direction, and the south side frame is reinforced with V-shaped steel bracings. On the north side, external steel bracings that are one-piece from 1 <sup>st</sup> floor to 3 <sup>rd</sup> floor are installed.

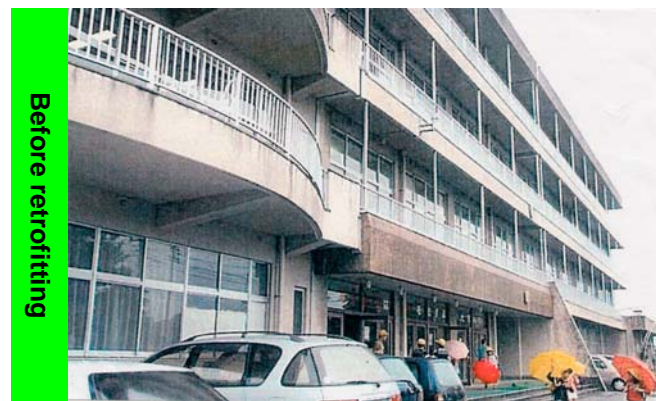
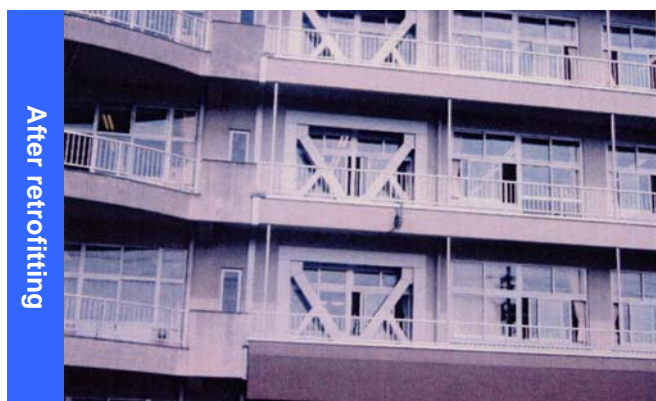
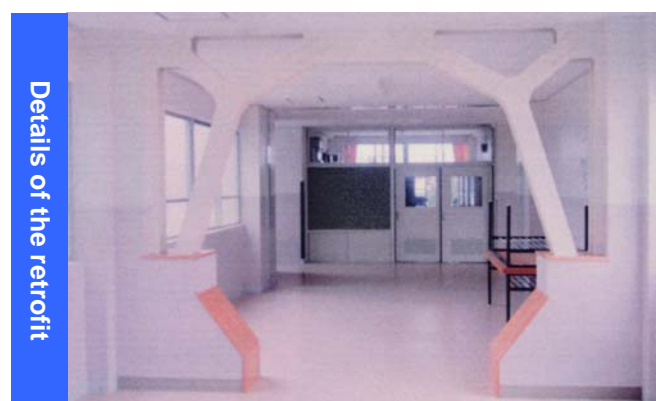
Toyama Pref	Toyama City, Hagiura Elementary School
<b>Outline of the facility</b>	Structure, Story, Floor area	RC structure, 4 stories Total floor area: 1,246 m <sup>2</sup>
	Work Duration	June 2002 to February 2003 (approx. 9 months)
	Total project cost	102.99 million yen
	Approx. cost of retrofitting	Install RC wall 78,800 yen/m <sup>2</sup> Install steel bracings 122,500 yen/m <sup>2</sup>
	<i>I<sub>s</sub></i> Value Before → After	$I_{sx} = 0.43 \rightarrow I_{sx} = 0.77$ $I_{sy} = 1.30 \rightarrow I_{sy} = 1.30$

<b>Outline of Seismic Retrofitting Method</b>	
Add shear wall in the ridge direction, to achieve strength increase type of retrofitting

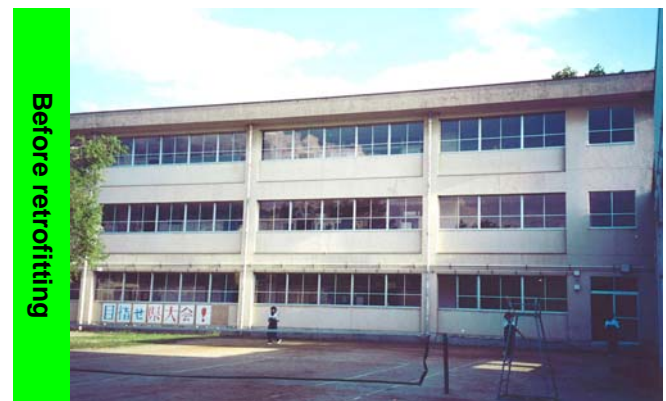
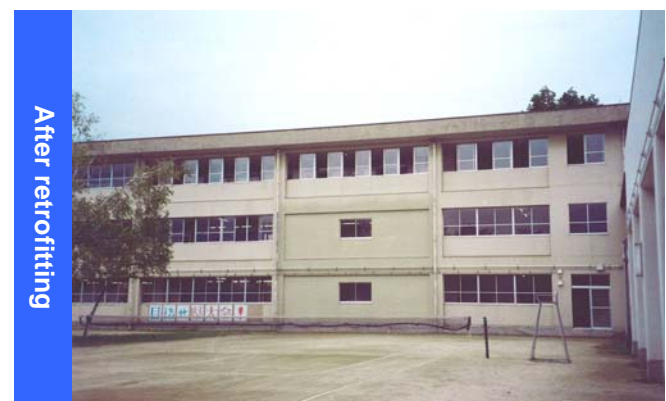
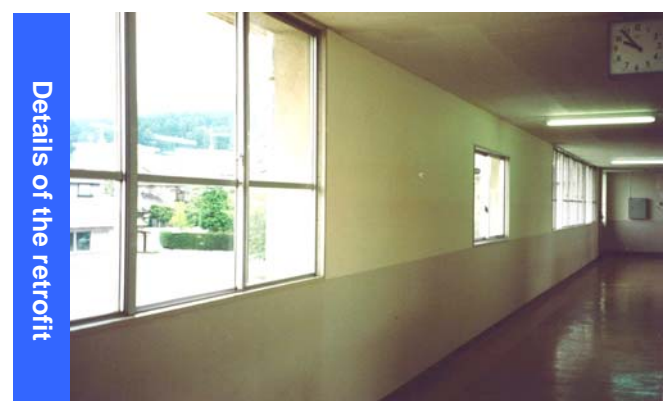
Nagano Pref	Matsumoto City, Meizen Junior High School
<b>Outline of the facility</b>	Structure, Story, Floor area	RC structure, 3 stories Total floor area: 2,105 m <sup>2</sup>
	Work Duration	June to September 2004 (approx. 4 months)
	Total project cost	Total project cost 42.735 million yen
	Approx. cost of retrofitting	Install RC wall 101,200 yen/m <sup>2</sup>
	<i>I<sub>s</sub></i> Value Before → After	$I_{sx} = 0.47 \rightarrow I_{sx} = 0.96$ $I_{sy} = 0.89 \rightarrow I_{sy} = 0.93$

<b>Outline of Seismic Retrofitting Method</b>	
Applied the common method of retrofitting and installed RC shear walls. Two seismic shear walls were added in the ridge direction at the first floor, as well as at the second floor.

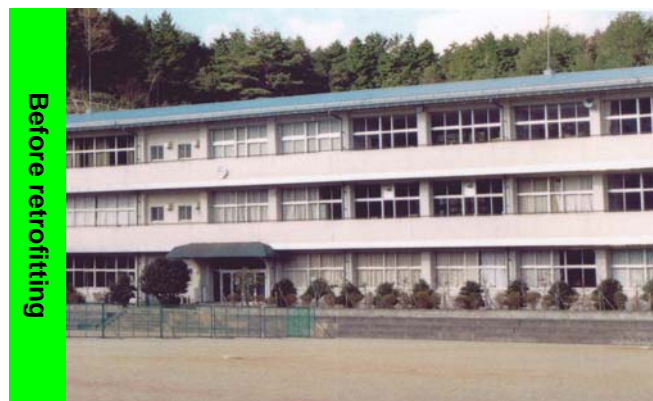
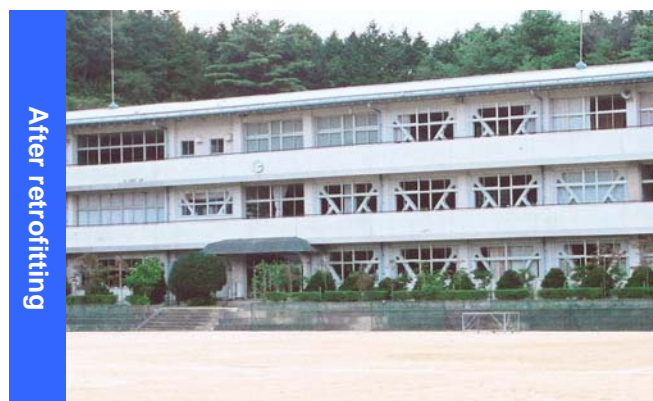
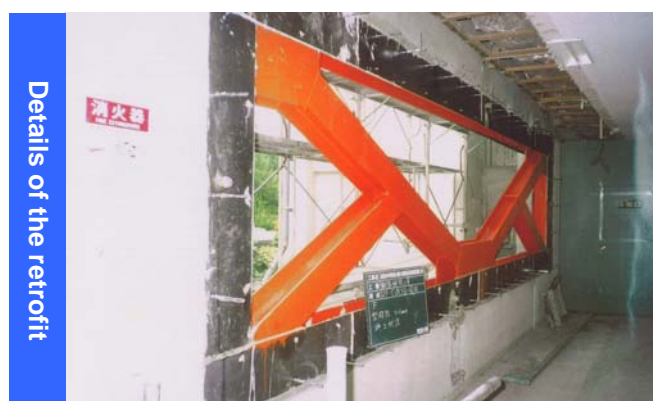
Toyama Pref	Koya Town, Koyasan Junior High School
Outline of the facility	Structure, Story, Floor area	RC structure, 3 stories Total floor area: 2,229 m <sup>2</sup>
	Work Duration	April to December 2004 (approx. 8 months)
	Total project cost	62.85 million yen
	Approx. cost of retrofitting	Steel bracings 184,000 yen/m <sup>2</sup> Structural slit 12,000 yen/each
	<i>I<sub>s</sub></i> Value Before → After	$I_{sx} = 0.46 \rightarrow I_{sx} = 0.90$ $I_{sy} = 1.06 \rightarrow I_{sy} = 1.06$

Install steel bracings at a total of 17 positions in the ridge direction. Vertical slits are placed on walls at the third floor to increase the ductility of columns.

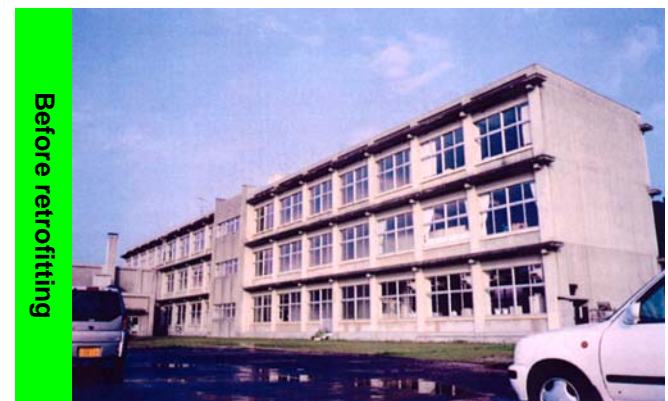
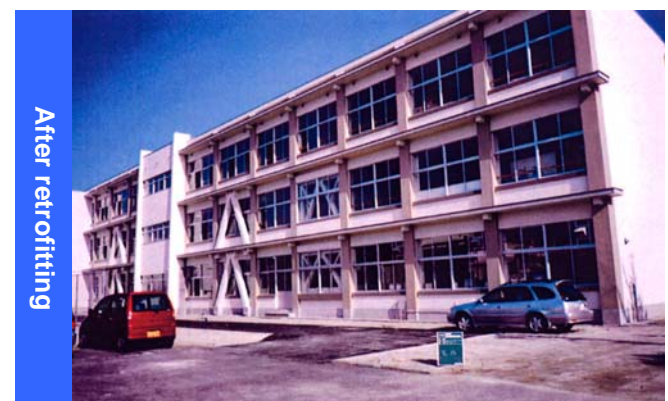
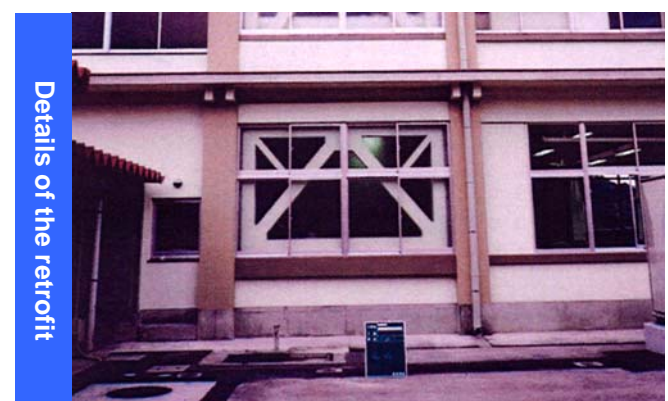
Tottori Pref	Nanbu Town, Hoshoji Junior High School
Outline of the facility	Structure, Story, Floor area	RC structure, 3 stories Total floor area: 2,281 m <sup>2</sup>
	Work Duration	July to August 2004 (approx. 2 months)
	Total project cost	264.81 million yen
	Approx. cost of retrofitting	Install wing walls 556,000 yen/each Steel jacket column reinforcement 1.131 million yen Precast bracings 2.071 million yen/each Steel bracings 1.912 million yen/each
	<i>I<sub>s</sub></i> Value Before → After	$I_{sx} = 0.39 \rightarrow I_{sx} = 0.75$ $I_{sy} = 1.34 \rightarrow I_{sy} = 1.34$

Installed steel framed bracings (8 positions) and precast bracing (1 position) in order to supplement the lack of strength at the first and second floor in the ridge direction. The independent column in the soft story is reinforced by wrapping with reinforced concrete and steel jacket, as well as installing wing walls to the column.

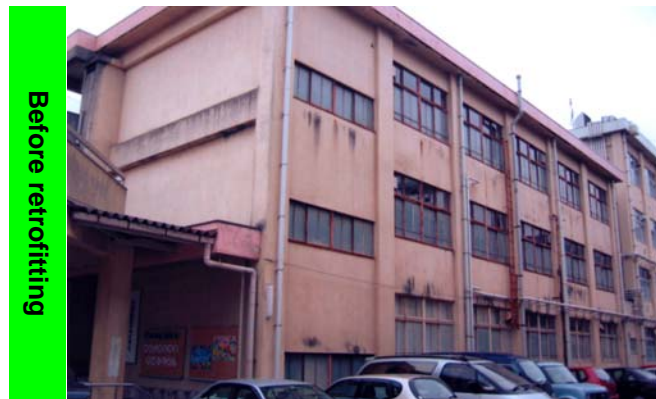
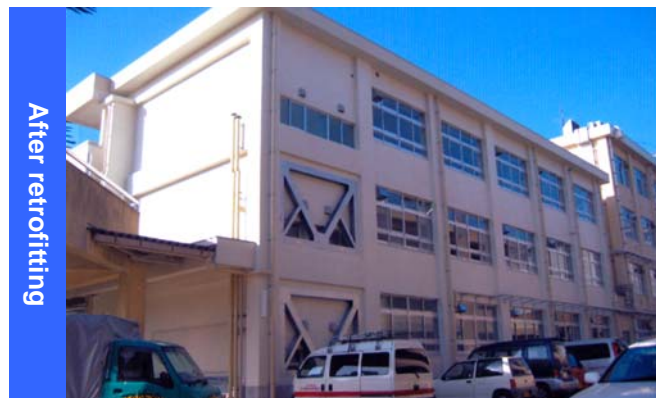
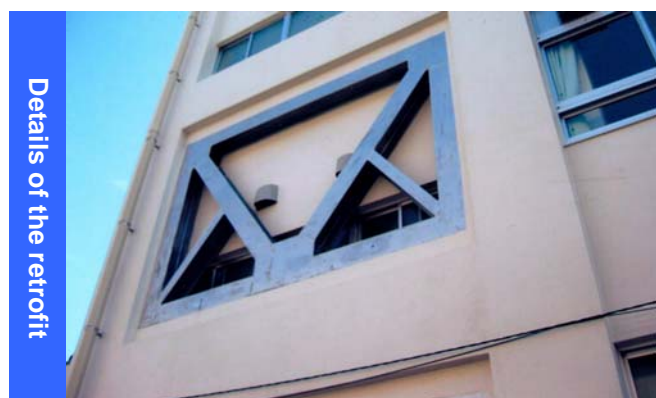
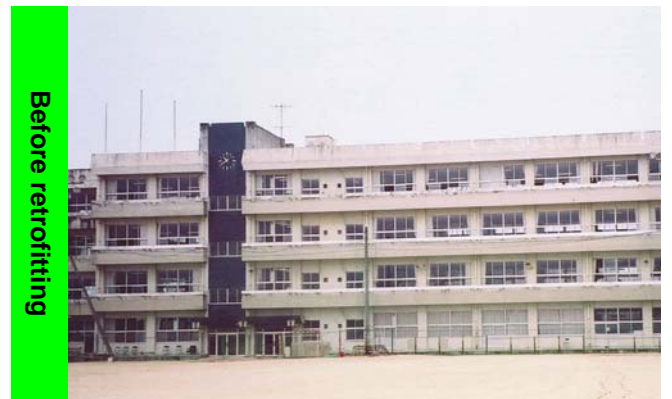
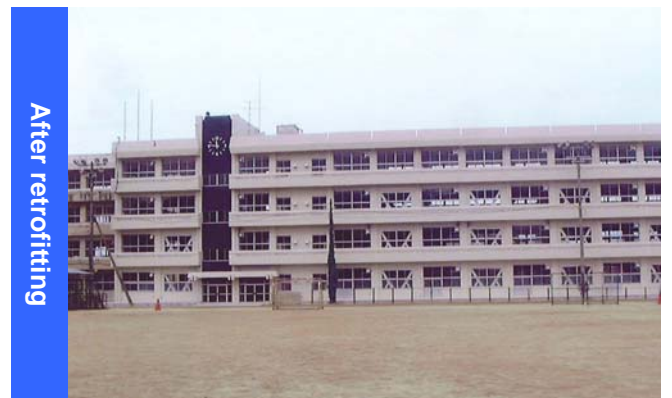
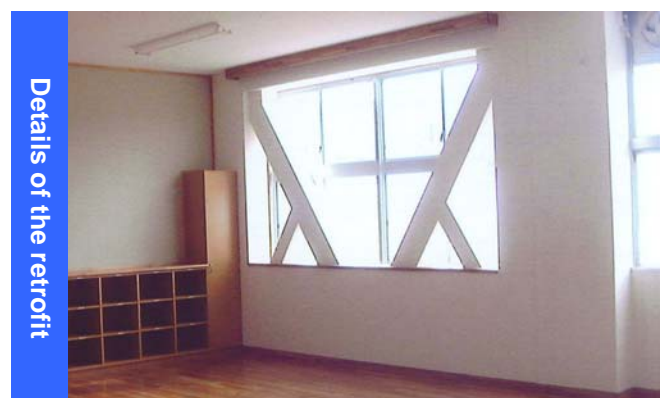
Outline of the facility	Structure, Story, Floor area	RC structure, 3 stories Total floor area: 576 m <sup>2</sup>
	Work Duration	July to November 2004 (approx. 5 months)
	Total project cost	Total project cost 7.688 million yen
	Approx. cost of retrofitting	Steel bracings 226,500 yen/m <sup>2</sup> Carbon fiber jacket column reinforcement 235,500 yen/m <sup>2</sup>
	<i>I<sub>S</sub></i> Value Before → After	<i>I<sub>SX</sub></i> = 0.33 → <i>I<sub>SX</sub></i> = 0.79 <i>I<sub>SY</sub></i> = 1.24 → <i>I<sub>SY</sub></i> = 1.28

Stable reinforcement is expected by having the steel frame retain strength and rigidity. Make wide openings to secure sufficient natural light and ventilation

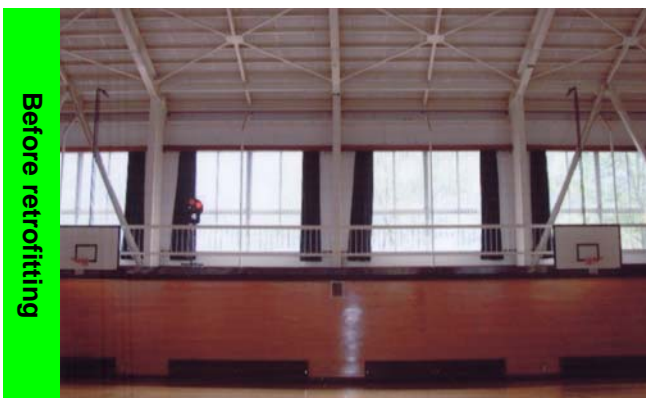
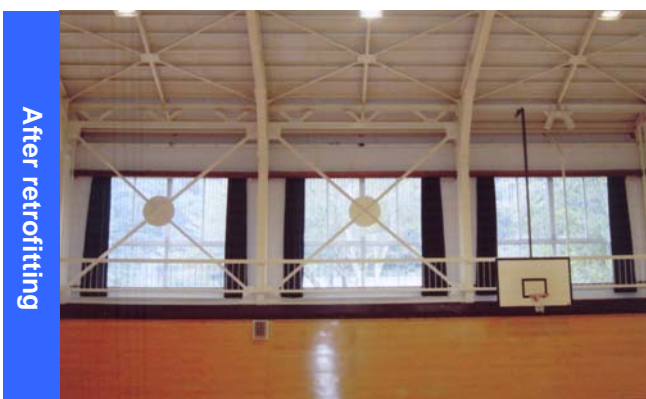
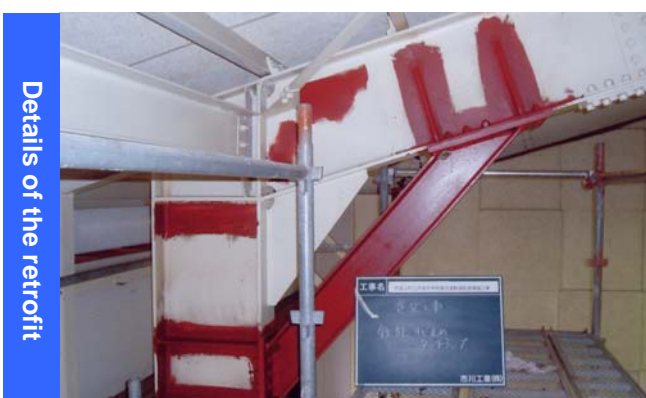
Yamanashi Pref	Tanbayama Village, Tanbayama Junior High School
Outline of the facility	Structure, Story, Floor area	Steel structure, 1 story Total floor area: 862.5 m <sup>2</sup>
	Work Duration	July to September 2004 (approx. 2 months)
	Total project cost	10.6 million yen
	Approx. cost of retrofitting	Column brace reinforcement 1.919 million yen/each Steel bracings 5.058 million yen/each
	<i>I<sub>S</sub></i> Value Before → After	$I_{sx} = 0.22 \rightarrow I_{sx} = 0.76$ $I_{sy} = 0.79 \rightarrow I_{sy} = 1.01$

Outline of Seismic Retrofitting Method	
<p>reinforcement at column head by adding knee brace (10 positions at the second floor) Bracings along side wall (4 positions at first floor and 4 positions at second floor)</p>

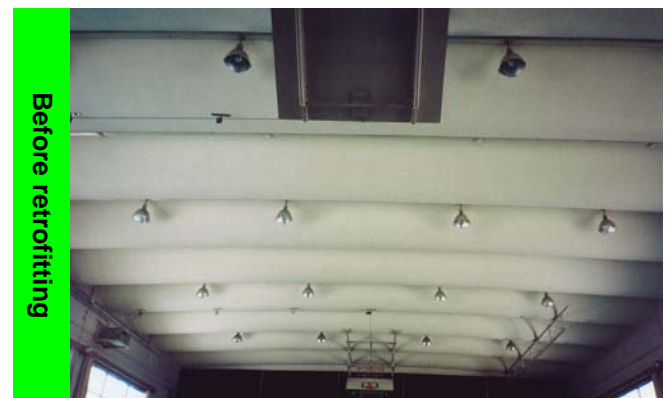
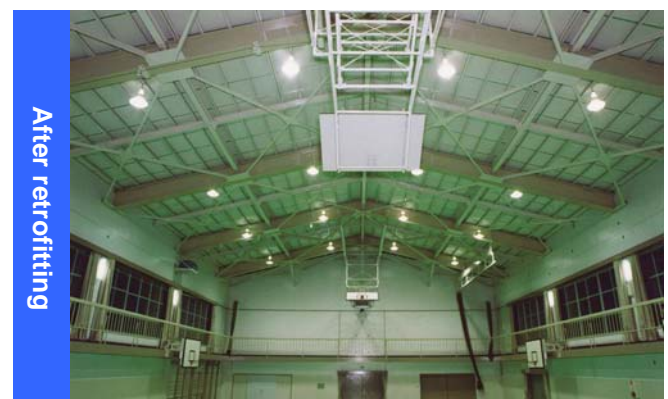
Aichi Pref	Nagoya City, Nakane Elementary School
Outline of the facility	Structure, Story, Floor area	RC and steel structure, 2 stories Total floor area 1,228 m <sup>2</sup>
	Work Duration	June 2003 to January 2004 (approx. 8 months)
	Total project cost	46.532 million yen
	Approx. cost of retrofitting	Remove the precast roof and replace with steel roof 76,000 yen/m <sup>2</sup>
	<i>I<sub>S</sub></i> Value Before → After	$I_{sx} = 0.17 \rightarrow I_{sx} = 0.81$ $I_{sy} = 0.17 \rightarrow I_{sy} = 1.76$

Outline of Seismic Retrofitting Method	
<p>Secure seismic capacity by removing the precast roof to prevent the roof from falling in and to reduce the dead weight.</p>

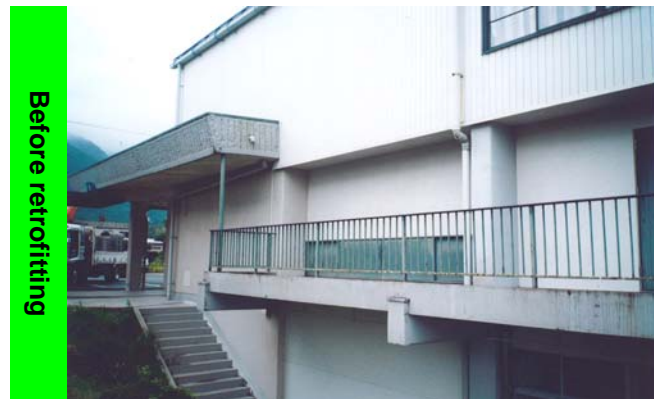
Before retrofitting

On the 2nd floor, to secure the view, natural light, and ventilation, steel bracings were used. The steel bracings allowed retrofitting without removing the openings at the periphery of the building that made the structure vulnerable to earthquakes. At the first floor, there was considerable displacement in the plan because of the shear wall. Therefore, reinforced concrete shear walls and steel bracings were installed to remedy the displacement as well as improve the strength and rigidity.
