# Seismic Retrofitting Quick Reference

## School Facilities that Withstand Earthquakes

# Introduction

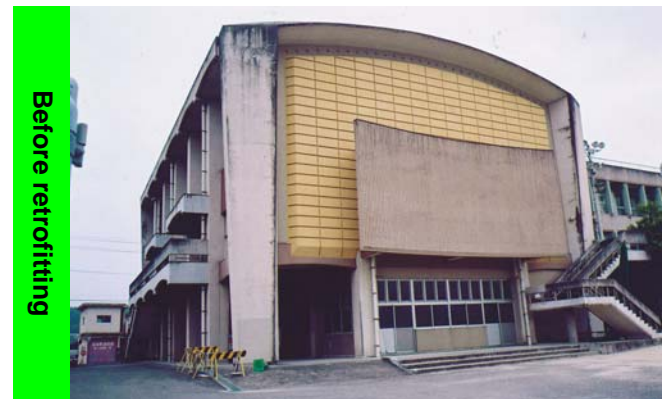
Before retrofitting

In the beam span direction, the structure is reinforced by installing K-shaped steel framed bracings at the first to third floors. The roof is reinforced by changing the steel bar bracings into steel angle bracings.

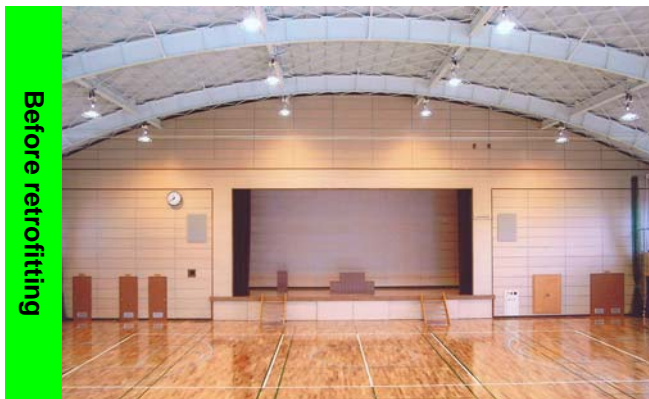
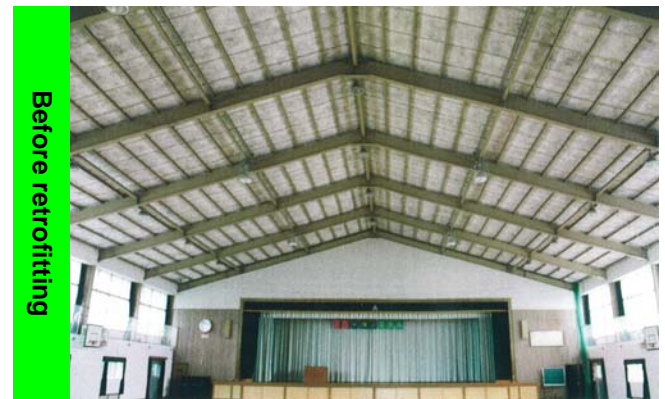
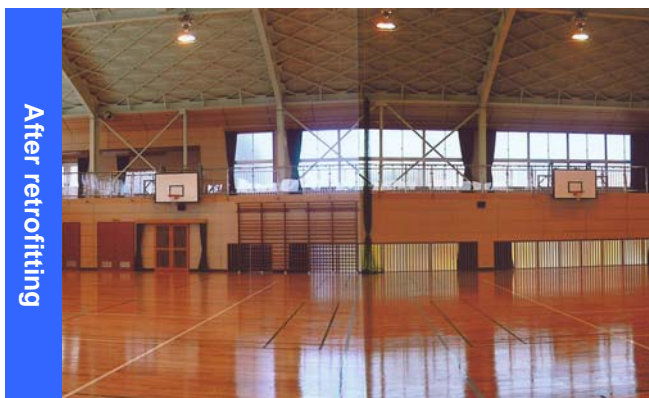
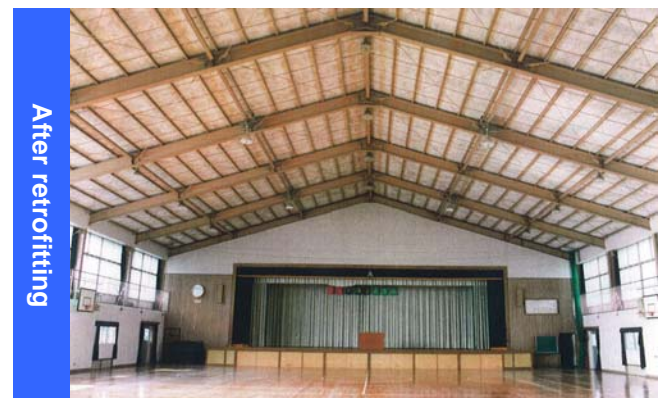
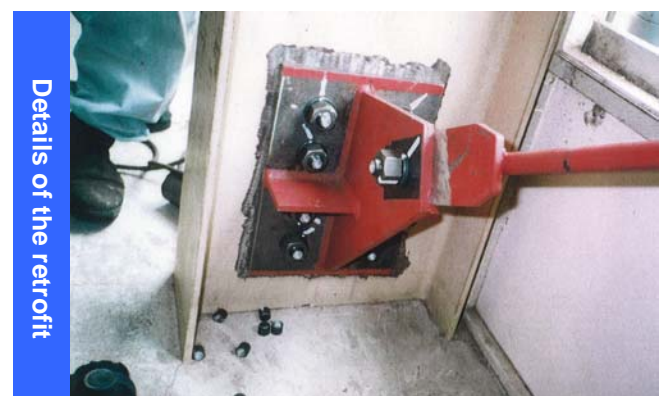
Outline of Seismic Retrofitting Method	
To increase the ductility of existing bracings, the brace member at 4 positions were changed. To increase strength, new bracings were installed at 4 positions.

Outline of Seismic Retrofitting Method	
Reinforcing by installing steel bracings to the roof and bracings were also added to the walls.
